INSTITUTE FOR FISHERIES RESEARCH
DIVISION OF FISHERIES
MICHIGAN DEPARTMENT OF CONSERVATION
COOPERATING WITH THE
UNIVERSITY OF MICHIGAN

November 18, 1938

REPORT NO. 499

NOTES ON RECENT INSTALLATIONS OF STREAM IMPROVEMENT BY MECW

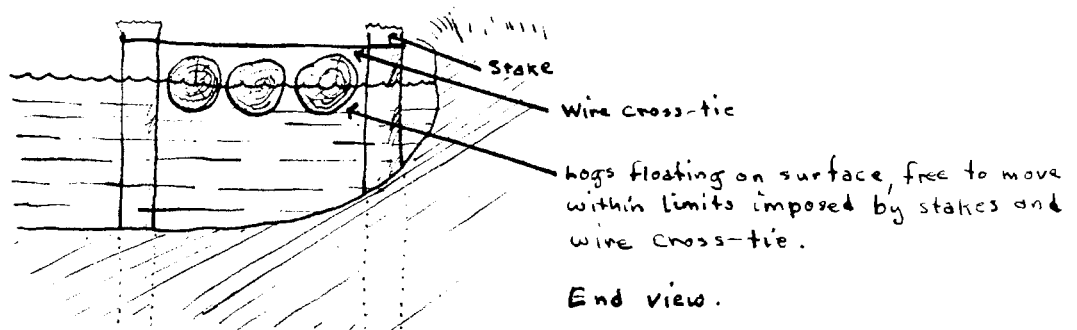
Pend rafts and bank covers in this section have been anchored ingeniously to allow their rising and falling with the current (see sketch).

If they are able to withstand ice action they should be very effective in providing much-needed shade and fish cover. It is probable that they will retard bank erosion, although complete stoppage is not to be expected unless they silt in, when their cover value will be destroyed.

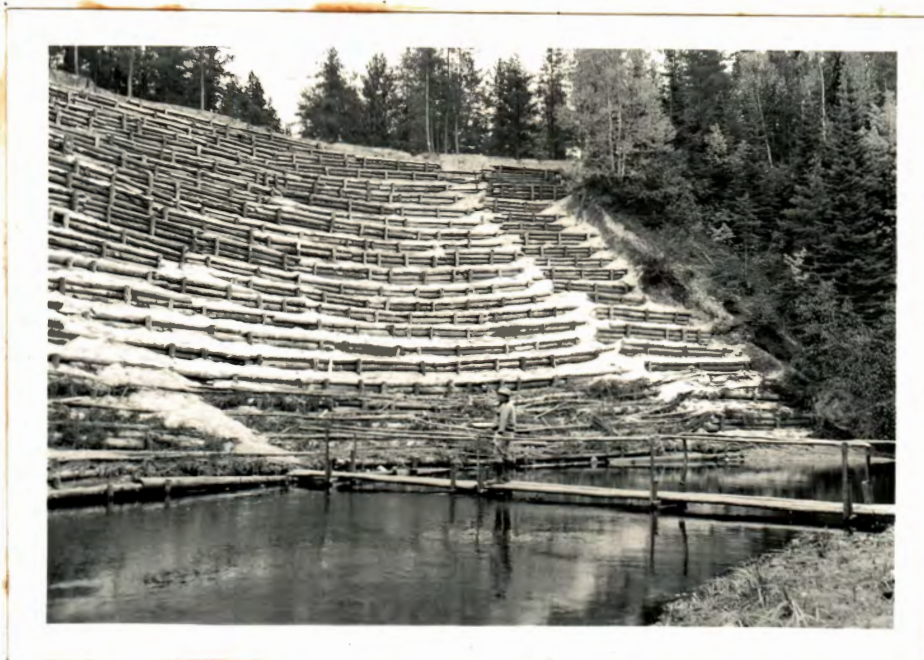
In this section the stream bottom contains considerable quantities of gravel and rubble. The banks, as shown in the photographs, are very high, steep, and badly eroded.

Log terraces, apparently quite stoutly constructed, are designed to hold back the sand until plantings or natural reproduction of grasses and shrubs become established sufficiently to bind the shifting slope. Sea walls

Installations made on the Two-Hearted during 1938 appeared to be more substantial than those of earlier years, where in one instance the sea wall has been damaged enough to allow resumption of current erosion. Most of the older work, however, is still holding. Bracken fern, Equisetum (horse-tail) and young aspen saplings are starting to establish (see photographs).

Recently completed erosion control work on Two Hearted River. Note tendency of sand to level off terraces.

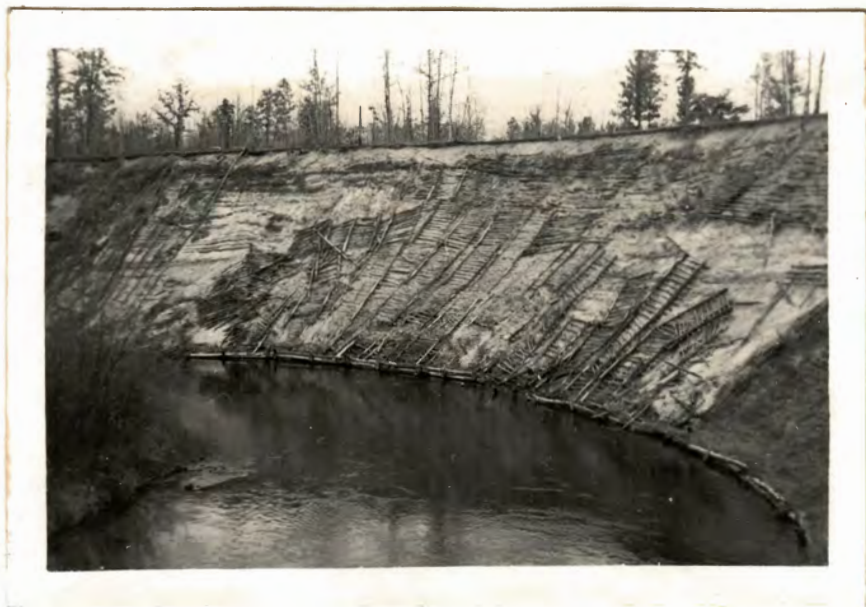
placed at the foot of the bluff are intended to arrest direct erosion by the current. Judged on the basis of comparable installations of previous years, notably those along the Pere Marquette River at Erwin's Bank and near the mouth of Kinne Creek, much of the future success of this work depends upon continued efficiency of the sea wall.

Erosion control work on Pere Marquette River just below mouth of Kinne Creek. Note points where sea-wall is broken. Age of work at time of photographing about four years.

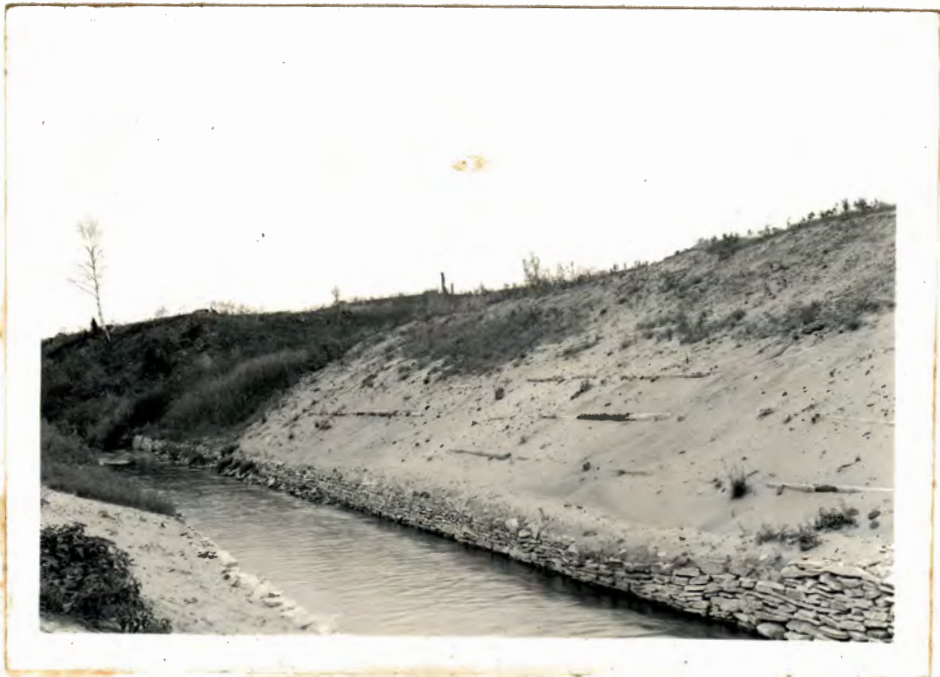
Erosion control work inspected at the Fox River Bearing Station shows the greatest promise of success because the sea wall is constructed solidly of limestone slabs, the natural force of the current is not great, and the sand slope is already supporting patches of sand-binding vegetation (see photograph). It is of interest to note in the photograph that the log terraces have been leveled off by sand filling almost to the normal angle of repose.

Erosion control along raceway, Fox River Rearing Station. Note stability of stone sea-wall, and establishment of vegetation on sand slope which has filled log terraces to normal angle of repose.

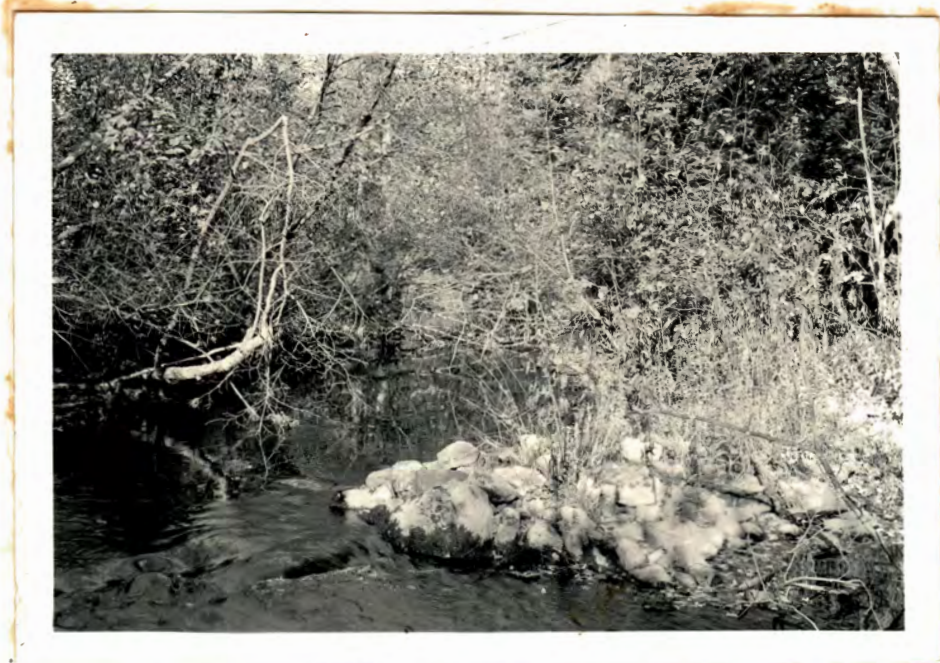
The section examined lies just below the U. S. 2 bridge in Mackinac County, T. 43 N., R. 8 W., Sec's. 19-20. Most of the structures, installed in 1935, are of two types: log and pole raft covers, and log-core boulder and stone wing deflectors. Those seen were in excellent condition, were operating efficiently, and presented a most pleasing, natural appearance (see photograph). This installation well exemplifies the claim that stone and boulder materials, when available in adequate size and abundance, lend themselves to effective, natural-appearing improvement devices much more readily than do wooden materials. From the standpoint of durability no complaint can be made. The work was inspected by one of the authors December 22, 1935, only a few months after its installation. In 1938, no apparent change could be detected.

Four year old log and boulder wing deflector in Mackinac County, Black River. This is one of the best possible types of construction if necessary materials are available.

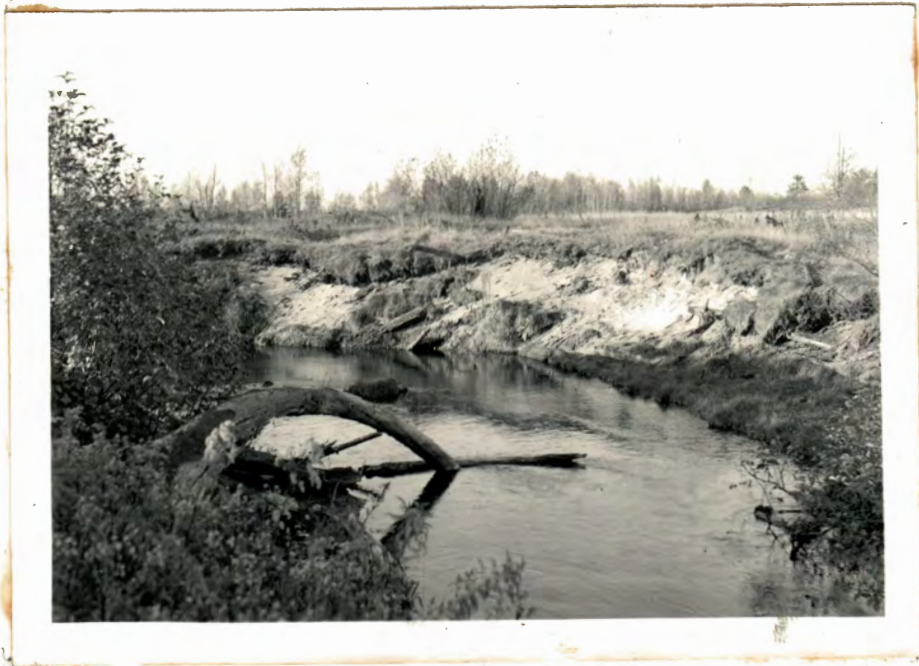
This river was inspected at a point a few miles northwest of Brevort. Here the work consisted of erosion control similar to that seen on the Two-Hearted but on a smaller scale, and of numerous deflectors, covers and rafts composed almost wholly of logs, poles, stumps and deadheads. Most of the latter have been covered with thick sod, which, however, was not wired down (see photograph). For this reason it is very likely that a large part of it will be ^{washed} ~~eroded~~ away by the action of ice and spring floods. Underpass logs, almost always of dubious value, may increase bank erosion in the section examined. Even these structures are sodded.

Sod covered bend raft in Carp River near Brevort. Unless sod is wired down it is certain to be damaged and stripped away by ice and high water.

5. Whenever it is thought desirable to cover improvement devices with sod, this should be wired in place by the use of binder poles to prevent its washing away with high water.

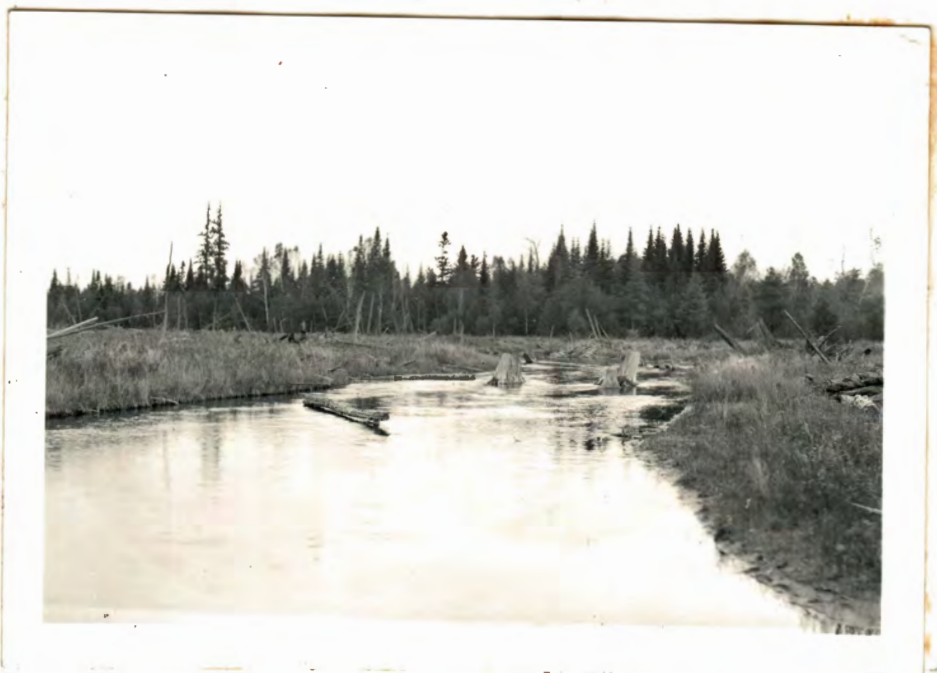
An inspection was made of work placed only a few miles below the source, in T 29 N., R. 4 W. Here the exceedingly tortuous channel winds through flat, open country, with very little natural shade. (The lack of shade is probably due to the old lumbering dam at DeWard, which, when still in place, flooded this section.) Large quantities of deadfalls are present and afford a certain amount of much-needed cover. Improvements (see photographs) have been constructed of available wooden materials and have been designed to restrict the rather wide, shallow channel (long wing deflectors) and to provide holes and cover (stumps and underpass deflectors.) In the main the structures are natural in appearance and are apparently durably constructed. The double construction of the underpass deflectors results in exposure above water of the upper element, lending a flavor of artificiality to an otherwise natural appearing series of devices.

Log and stump barriers in Manistee River west of Gaylord. In the main, these structures are in harmony with their surroundings, and seem to be performing as expected. Isolated digging logs, as seen in the foreground, are of questionable value.

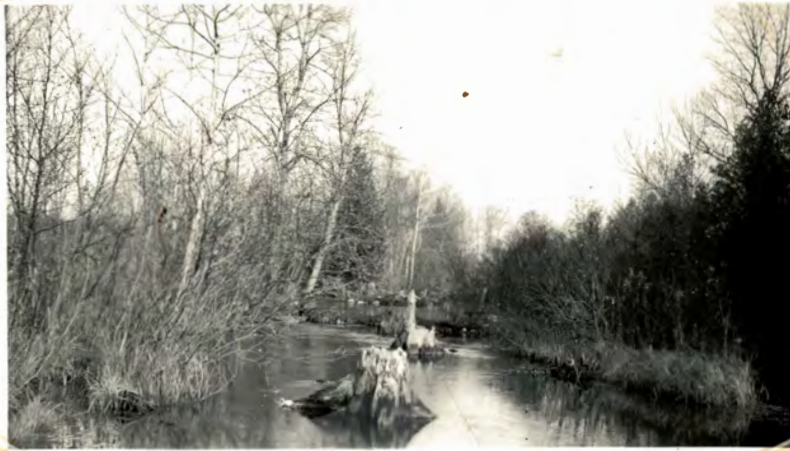
The improvements consist chiefly of long wing deflectors of logs banked with gravel; V deflectors similarly constructed; and submerged digging logs designed with the hope that they would create openings in the weed beds. Some of the deflectors direct the current under moored stumps or digging logs. Long wings and the broad, obtuse-angled V-deflectors are of a type which has proven successful in the Lovells section of the North Branch. Near Bottell's the materials used seemed none too sturdy, and final judgment must be withheld until they have gone through a winter. This stream is not normally subjected to heavy flooding or ice action, so the work may hold without damage. The digging logs have been able to clear weeds from only that portion of bottom lying under the log and extending for about 12 to 15 inches below it. Stumps and digging logs at the ends of deflectors are likely to meet the fate already predicted for similar devices in the Big Betsy River.

North Branch Au Sable near Boutell's cottage. These wing deflectors should do good work, although the sod should be held on with binding poles. Digging logs at end are of questionable value.

Sod placed on the North Branch structures should be wired in place by binder poles.

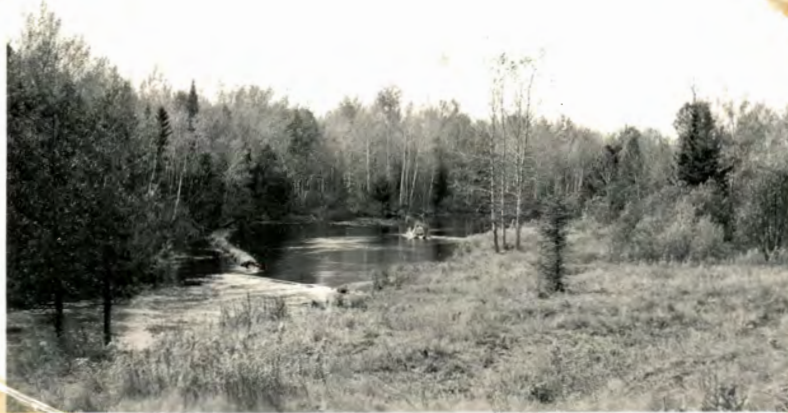
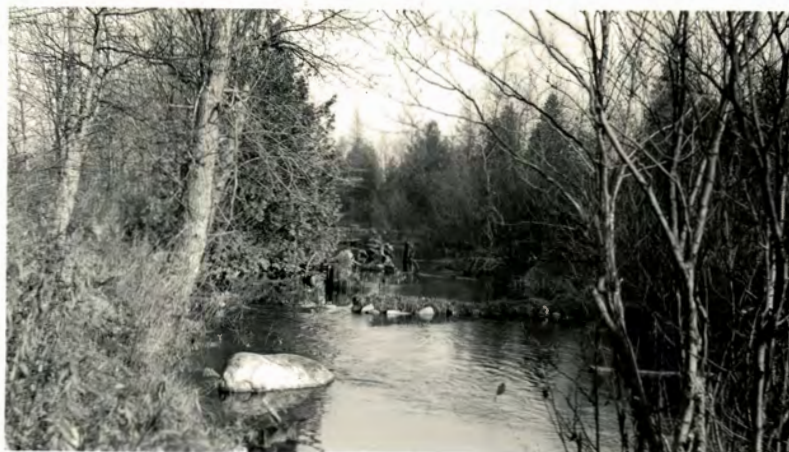
Structures in Tobacco River below rearing station.

(Examined by Hazzard and Trautman, November 1, 1938). Improvements in this stream were inspected just below the state trout rearing station. The work, consisting largely of dams with central or lateral spillways, and anchored stumps, is without doubt the sorriest example of stream improvement thus far observed. The rocks employed are very small (no larger than a man's head), and have been taken from the stream bed, despite the fact that an ample supply of large boulders is available along the road near the stream. Numerous pine deadheads were observed along and in the stream above the rearing ponds.

In addition to the above, the work is poorly constructed and too much concentrated. It is likely that most of it will go out with the spring rains.

Boulder or log wing deflectors used in conjunction with bank and bend rafts would be much more suitable barrier types for this stream. The low-center rock dams as installed above the rearing station are very natural in appearance, and should also be a desirable type of improvement for this stream.
