March 14, 1951

Report No. 1280

EXPERIMENTAL OPERATION OF BLACK  
RIVER SEA LAMPREY BARRIER DAM

Thomas M. Stauffer

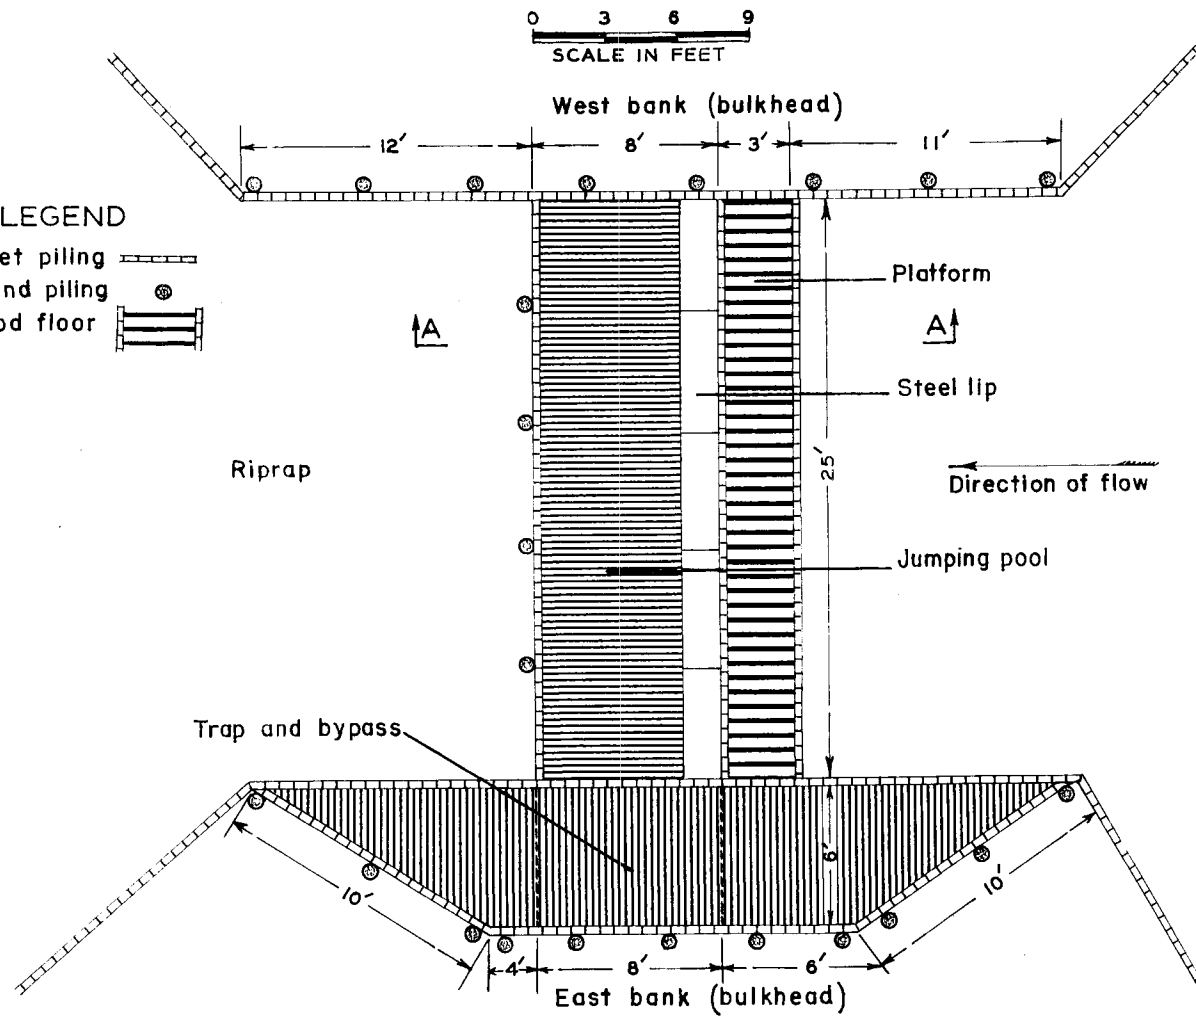
Figure 1

PLAN VIEW OF BARRIER DAM

Adjoining the jumping pool on the east side was the trap and by-pass. These, too are floored. The upstream and downstream walls of the trap are indicated by a broken line in the plan view. The planks (splash boards) making up the walls can be removed, thus converting the trap into a by-pass. When these splash boards are removed, the impoundment empties rapidly, and soon all the flow is through the by-pass. That is, if there is not too much water in the river. The by-pass is completely floored to the points of the east bulkhead. In the middle wall of the dam, which is the west wall of the trap, is the entrance to the trap. On May 29 a wire funnel was attached to the inside of the hole. This would prevent escapement of upstream migrants, when they found themselves in the trap. In operation, a small amount of water was let into the trap over the upstream wall. This water flowed out of the entrance of the trap, where presumably it would attract upstream migrants.

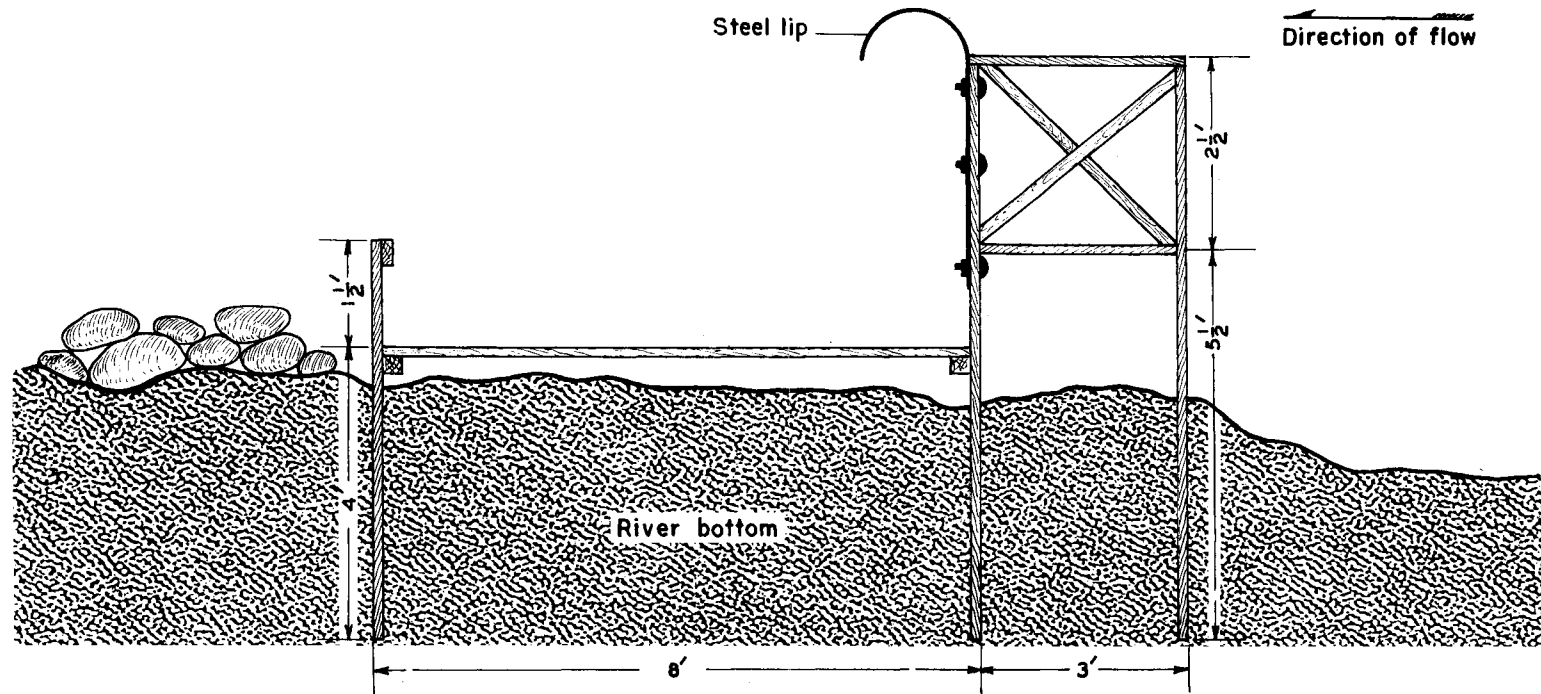
Figure 2

SECTION VIEW OF BARRIER DAM  
SECTION A-A

Immediately downstream and under the curved steel lip was the jumping pool. This was designed to insure an adequate depth of water for the rainbow trout to jump from. This pool has a wooden floor. The depth of water in this pool varied from 19 to 34 inches, depending on the level of the river. In the period May 18 to June 7 the jumping pool water depth was 20 to 24 inches. June 7 a 6-inch plank was added to the downstream wall and consequently the depth increased 6 inches. After this date the water depth in the jumping pool hovered around 27 inches.

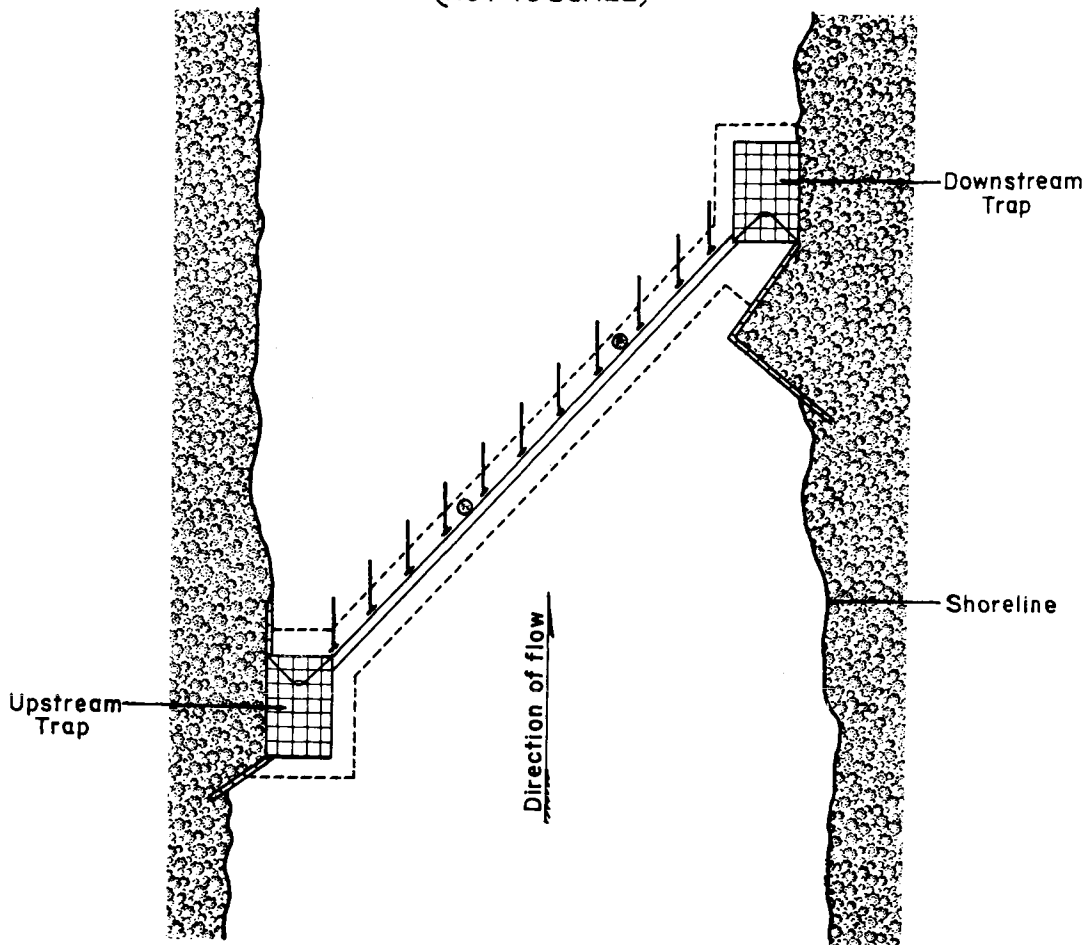
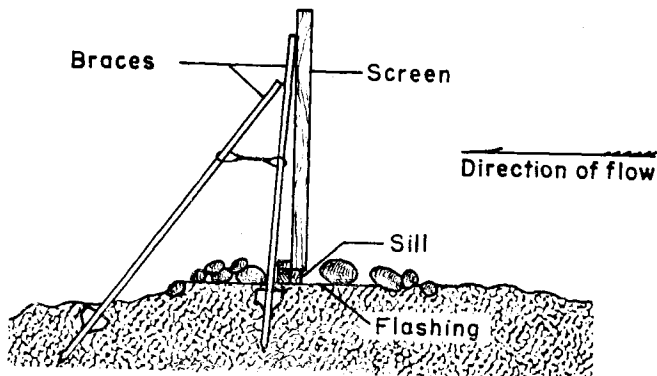
Figure 3

# CHECKING WEIR

DIAGRAMMATIC PLAN VIEW  
(NOT TO SCALE)
