REPORT NO. 965

INVESTIGATION OF McCORMICK LAKE OUTLET DAM,
MONTMORENCY COUNTY (T. 30 N., R. 2 E., Sec. 30, SW 1/4)

David S. Shetter

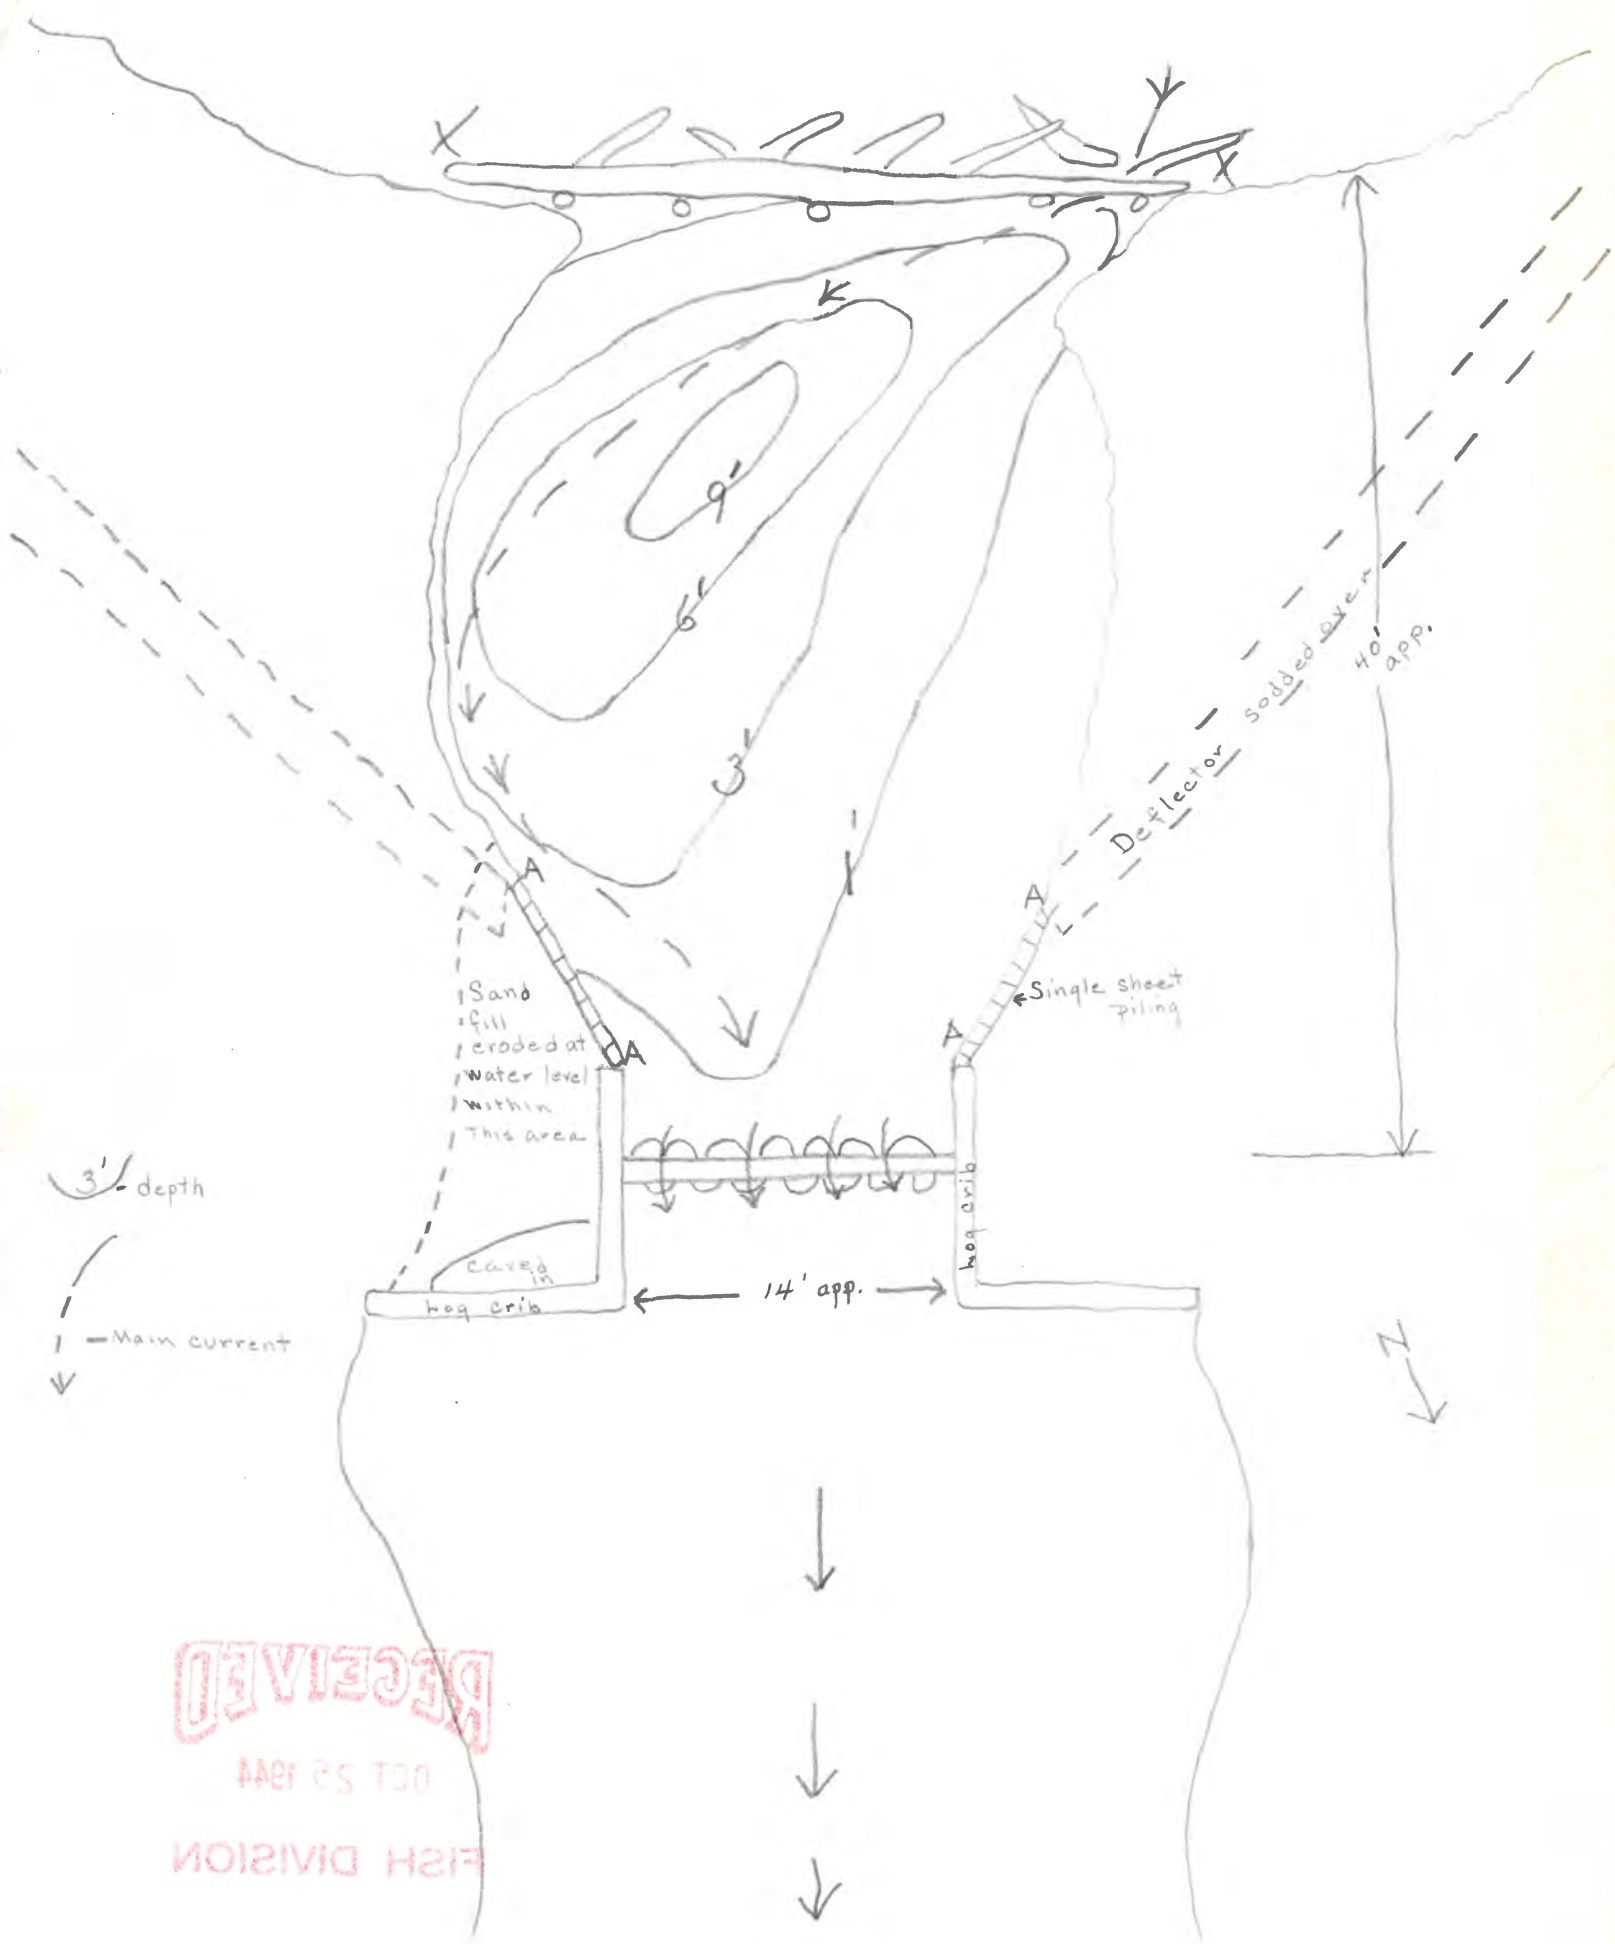
There is some failure of the structure on the east side. Water currents have worked behind the single sheet piling (A-A) and has washed the sand fill from inside the lower level of the log cribbing. This has increased

the amount spilled out of the lake by about 25 per cent, and is the leakage which Mr. Morine complains of. There is some indication that muskrat, mink or otter burrowing may have started the subsurface erosion. However, the condition is not of recent origin, since Mr. Morine stated that he had known of the existence of the leak for the last 1 1/2 years.

According to Mr. Morine when the original dam was installed by the CCC the water level created in McCormick Lake was not satisfying to the land owners surrounding the lake. At their request the CCC returned to correct the condition. The measure applied was to stake a boom log (indicated by X-X in the diagram) and pile driftwood in front of it. This raised the level of the lake possibly one or maybe even two inches according to Mr. Morine.

However, this barrier set up enough of a current, particularly in times of high water, to dig out a deep hole between the dam proper and the boom. The leak in the dam originates where the lower end of the deep hole meets the dam face (see diagram).

Since the State of Michigan has a considerable interest in McCormick Lake, some corrective measures should be applied if possible before further deterioration reduces the effectiveness of this retaining structure. I

would suggest that the structure and general surrounding area be inspected by the Fish Division engineer, Mr. Floyd Fanselow, and his suggestion for repair or revision be followed.
