LAND CORNER RECORDATION CERTIFICATE  
Filing Requirement of Act 74, Mich. P.A. 1970

DELTA  
(County)

F-1 [N1/4 COR SEC 4] F-3 [N1/4 COR SEC 9]

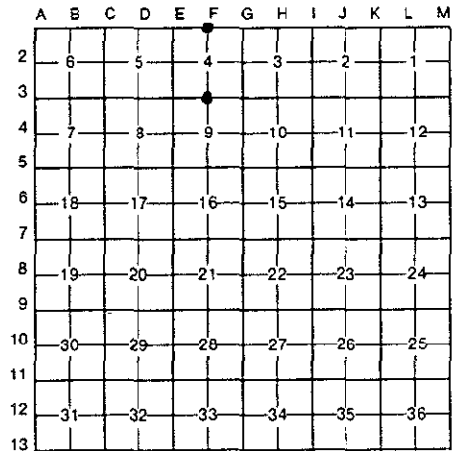
F-1 [N1/4 COR SEC. 4] JOHN BURT, DS-1845-SET WOOD POST (CEDAR 09° N20°E 10 LINKS)(CEDAR 05° N59°W 14 LINKS)  
NO RECORD EVIDENCE OF CORNER RECOVERY AND/OR SUBSEQUENT MONUMENTATION

F-1 [N1/4 COR SEC. 4] NO CORNER EVIDENCE FOUND. REESTABLISHED CORNER POSITION AT BASE OF LARGE CORNER FENCE POST (DOWN) AT JCT OF ANCIENT FENCE LINES (N & W) WHICH ARE DOWN AND IN POOR REPAIR. AS THE CORNER POST FOUND IS SIMILAR IN SIZE & NATURE TO OTHERS FOUND THROUGHOUT THIS FARMLAND AREA WHERE CORNER MONUMENTATION WAS FOUND TO EXIST I HAVE ACCEPTED THIS POSITION TO BE THE BEST AVAILABLE EVIDENCE AS TO THE LOCATION OF THE POSITION OF THE ORIGINAL CORNER.

F-1 SET A BERNTSEN A1NB30 ALUM MONUMENT W/A 3 1/4" CAP STAMPED TO ID THE CORNER POSITION.  
ASH 05" ASPEN 06" CEDAR 08" CEDAR 04" SURVEY MONUMENT SIGN POST  
N24°E S52°E S24°W N62°W SOUTH  
53.45' 04.24' 52.48' 67.72' 1.20' (TO FACE)
