**SURVEY &
REMONUMENTATION**

**LAND CORNER RECORDATION CERTIFICATE
Filing Requirement of Act 74, Mich. P.A. 1970**

Leelanau
(County)

| 1. Public Land Survey | | <u>T30N R 11W</u> | <u>E-10</u> |

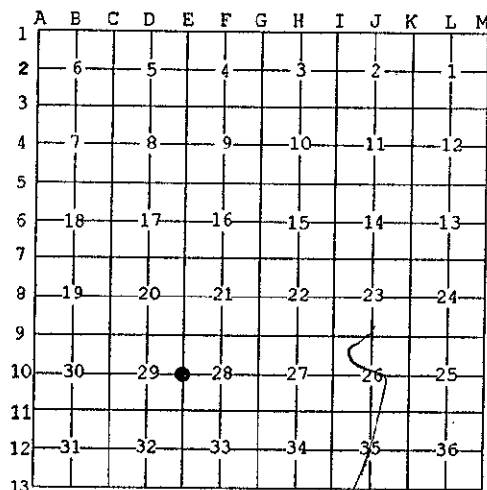
- E-10: 1/4 Corner Common To Sections 28 and 29
Found 1/2" Iron Pipe below surface of road.
Power Pole, N40°W, 31.32'
Telephone Pole, S10°E, 115.39'
Power Pole, N40°E, 28.32'
8" Cedar, S59°W, 55.82'

- E-10: 1/4 Corner Common To Sections 28 and 29
1/2" Iron Pipe accepted as the best available evidence of the position of the original corner by the Leelanau County Peer Review Group on December 1, 1997. Replaced with a 3/4" I.D. by 3.0' long galvanized iron pipe with stamped brass cap and set in a pavement box.
Power Pole, N40°E, 28.32' 5'± West of Centerline of Elm St. to S
Telephone Pole, S10°E, 115.39' In Centerline of Broadway.
8" Cedar, S59°W, 55.82'
Power Pole, N40°W, 31.32'
