LAND CORNER RECORDATION CERTIFICATE Filing Requirement of Act 74, Mich. P.A. 1970

Table with columns: For corners in (MENOMINEE County), Located In: (T38N R 27W), Corner Code # (I-05). Rows include Public Land Survey, Property Controlling in Section, and Miscellaneous Property in Sec.

I, William Lenca, in a field survey on Sept 11, 19 97 do hereby state that under requirements of P.A. 74, Michigan P.A. of 1970, the corner points mentioned in lines 1 and 2 above were in conformance with regulations and rules therefore as required in the current manual of survey instructions of the United States Department of the Interior, Bureau of Land Management or by a decree of a Court of Law and for that the corner points mentioned in lines 3, 4 and 5 above were in conformance with the rules of the Michigan Board of Land Surveyors or by a Decree of a Court of Law; established, re-established, monumented, recovered, found as expressed below:

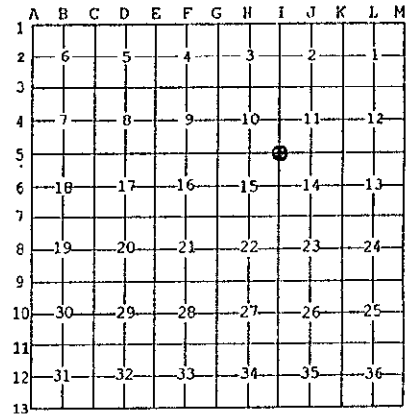
- 1852: Original Survey by Harvey Mellon - B.T.'s - Cedar, 10" - N13.5°W - 23 lks.; Cedar, 10" - S23°E - 15 lks. All original evidence for this corner has been destroyed by logging activities.
1978: L.C.R.C. No. 179, recorded by Robert Perkins, states he set a 4" x 4" x 36" concrete monument with a brass cap at point of corner post of ancient fence corner - fences run N - S - E - W. WIT: 6" Tamarack - S06°W - 88.35'; 5" Cedar - S43°E - 118.50'; 6" Dbl. Cedar - S87°W - 234.0'.

Perkins Corner was destroyed in 1981 by the construction of a Sewage Lagoon. However, prior to the beginning of construction, concrete witness monuments were set by Coleman Engineering at locations 220.42 feet West, 150.00 feet South, 999.95 feet North and 480.10 feet East. The corner re-established from these witness monuments matches with distances to corners shown on the back of L.C.R.C. No. 179. We accepted the position established by Robert Perkins as the best available evidence of the position of the original corner.

C. Description of monument for corner and accessories established to perpetuate locating the position of the corner: Corner falls in sewage lagoon - No monument set at Corner position:
