SURVEY & REMONUMENTATION

LAND CORNER RECORDATION CERTIFICATE
Filing Requirement of Act 74, Mich. P.A. 1970

Missaukee (County)	Located In:	Corner Code #
1. Public Land Survey	T 23N R 5W	M-8
	T R	
2. Property Controlling in Section	S T R	
	S T R	
3. Miscellaneous Property in Sec.	S T R	
	S T R

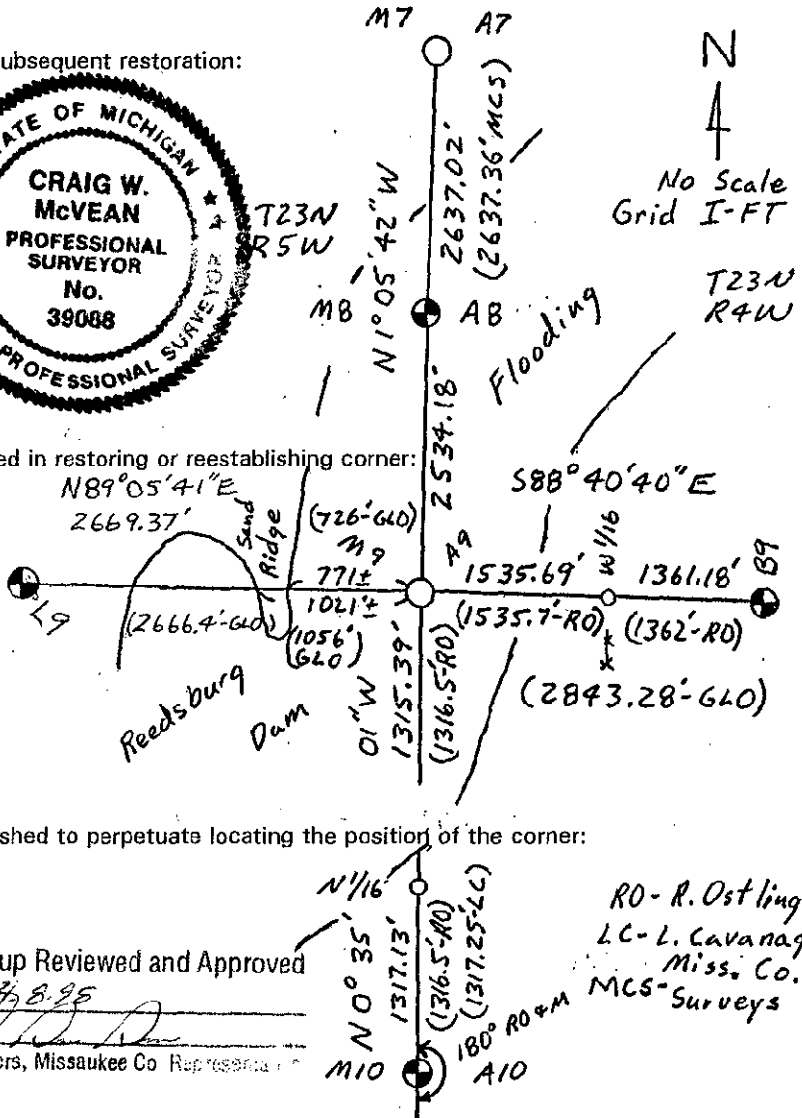
- M-8 - Standard 1/4 Corner Common to Sec. 19, T23N, R4W & Sec. 24, T23N, R5W. Corner Position is under water in Reedsburg Dam Flooding - 10' ± Deep. Corner position is calculated on line between A7 and calculated position at A9 (Also in flooding) at Record County Distance South from A7. Calculated Position accepted as a careful and faithful re-establishment of the position of the original corner.

- M-8 - No Monument Set - Falls in Flooding. MI State Plane Coordinates Central Zone NAD 83 (1994) X = 19557284.52 I-FT. Y = 384990.62 I-FT. See Diagram for Witness Ties.
