**BARRY COUNTY REMONUMENTATION
LAND CORNER RECORDATION CERTIFICATE
Filing Requirement of Act 74, Mich. P.A. 1970**

For corners in
BARRY
(County)

| 1. Public Land Survey | T <u>1N</u> R <u>10 W</u> | D-5 |
| | T _____ R _____ | <u>PRAIRIEVILLE</u> |

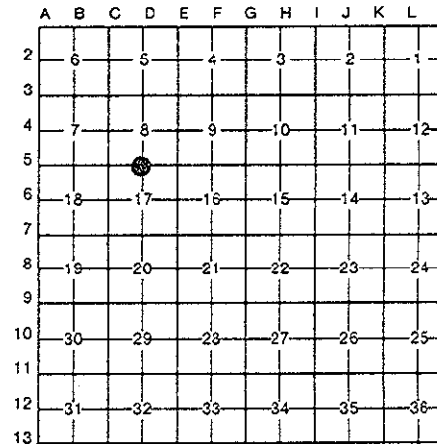
FOUND 1/2" CAPPED IRON (CAP #20704-CARR) AT MID-POINT OF LINE FROM C-5 TO E-5.

CORNER IS ON VERY STEEP SLOPE NORTH OF EAST-WEST GRAVEL ROAD. IT APPEARS THAT THE SPOILS OF GRADING THE ROAD HAVE BEEN SPILLED OVER THE BANK OF THE SLOPE. IF THE TILE BY CRESSY REMAINS (WHICH IS DOUBTFUL) IT WOULD BE UNDER SEVERAL FEET OF SPOILS, IN A POSITION WHICH RENDERS IT EXCEEDINGLY IMPRACTICAL TO EXCAVATE FOR.

ACCEPTED THE FOUND 1/2" IRON AS THE BEST AVAILABLE EVIDENCE OF THE CORNER POSITION.

REPLACED FOUND 1/2" IRON WITH STANDARD 3/4" REMONUMENTATION IRON AND ALUMINUM CAP.
40D NAIL AND WITNESS TAG IN NORTH SIDE OF 15" BLACK WALNUT N62°E 58.32'
40D NAIL AND WITNESS TAG VERTICAL IN CENTER OF GUARD RAIL POST S30°W 16.50'
40D NAIL AND WITNESS TAG IN NORTH SIDE OF 10" CHERRY WEST 10.48'
40D NAIL AND WITNESS TAG IN WEST SIDE OF 12" BLACK WALNUT N17°W 31.34'
±32' NORTH OF CENTERLINE OF FOUR MILE ROAD
