LAND CORNER RECORDATION CERTIFICATE

Filing Requirement of Act 74, Mich. PA 1970

For Corners In: Benzie (County)	Located In	Corner Code #
1. Public Land Survey	T <u>26N</u> R <u>14W</u> <u>K4</u>	
	T _____ R _____	
2. Property Controlling in Section	S _____ T _____ R _____	
	S _____ T _____ R _____	
3. Miscellaneous Property in Section	S _____ T _____ R _____	
	S _____ T _____ R _____

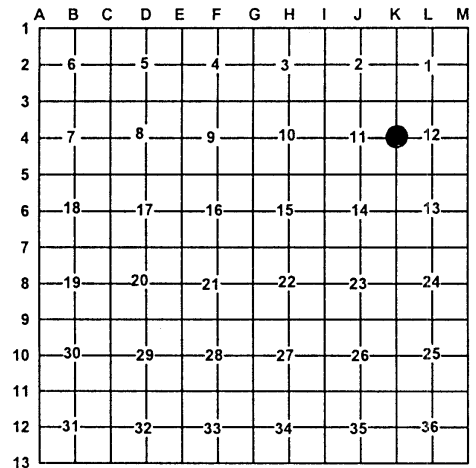
K4 – ¼ Corner common to Sec. 11 & 12 – Fd. 3 ¾" Brass Cap on 4" Octagon Conc. Mon. by Shadko and used by Case & Livasy.
 LCRC by Bruning appears to be in error. Didn't find any evidence of the Bruning 5/8" rod or his witnesses. Shadko Mon. accepted as the best available evidence of the position of the original corner.

K4 – 3 ¾" Brass Cap on 4" Octagon Concrete Mon.
 Set Blue Carsonite Post 1' N
 N30°E 35.00' to set N & T in W. side 10" SD. Maple (GAS)
 S83°E 6.44' to set N & T in N. side 10" Hemlock scribed 'XBT'
 S20°W 10.85' to set N & T in E. side 12" R. Maple (PC)
 N10°E 16.77' to set N & T in W. side 10" S. Maple (PC)
 S87°W 42.89' to fd. nail in N. side 33" Hemlock (GAS, PC)
 N39°W 26.74' to fd. nail in NE side 10" R. Maple (PC)
