LAND CORNER RECORDATION CERTIFICATE
Filing Requirement of Act 74, Mich. P.A. 1970

For corners in
DELTA
(County)

G-6 [W1/4 COR SEC 15] G-7 [NW COR SEC 22]

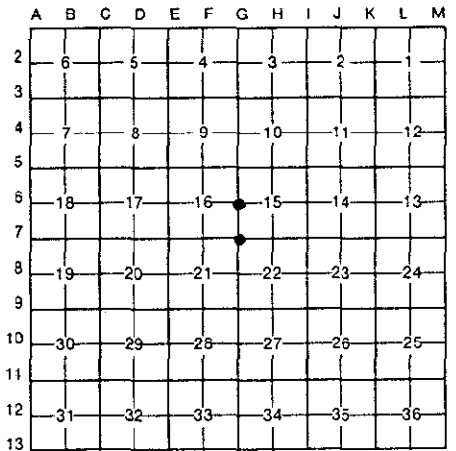
G-6 [W1/4 COR SEC. 15] NO CORNER EVIDENCE FOUND. REESTABLISHED CORNER POSITION IN LINE WITH ANCIENT FARM FENCE LINE TO THE EAST & 1/2 DISTANCE BETWEEN N-S COUNTY RD R/W FENCE LINES. ACCEPTED THIS POSITION AS BEING THE BEST AVAILABLE EVIDENCE AS TO THE LOCATION OF THE POSITION OF THE ORIGINAL CORNER.

G-6 SET A 5/8" X 18" REBAR W/A 3/4" ALUM CAP STAMPED TO ID THE CORNER POSITION.
CEDAR 09° N58°E 77.40' CEDAR 05° S58°W 75.18' 5/8" X 18" REBAR W/A 2" ALUM WIT CAP N63°E 32.15' SURVEY MONUMENT SIGN POST EAST 22.20' (TO FACE)
