**SURVEY &  
REMONUMENTATION**

**LAND CORNER RECORDATION CERTIFICATE  
Filing Requirement of Act 74, Mich. P.A. 1970**

<u>Leelanau</u> <small>(County)</small>	Located In:	Corner Code #
1. Public Land Survey	<u>T 28NR 11W</u>	<u>E-7(Elmwood Twp.)</u>
	T ___ R ___	_____
	T ___ R ___	_____
	T ___ R ___	_____
2. Property Controlling in Section	S ___ T ___ R ___	_____
	S ___ T ___ R ___	_____
3. Miscellaneous Property in Sec.	S ___ T ___ R ___	_____
	S ___ T ___ R ___	_____

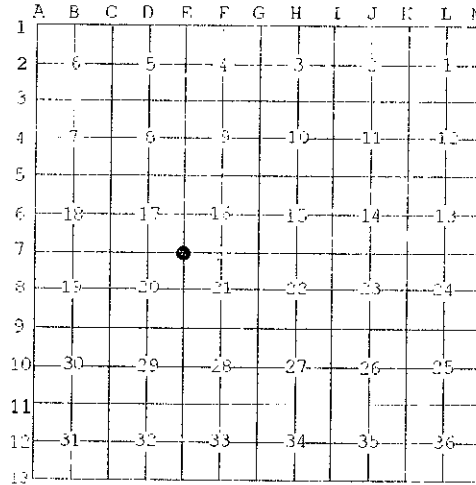
B. Description of corner evidence found and/or method applied in restoring or reestablishing corner:  
E-7: Southeast corner of Section 17.

Found iron pipe 0.5' North of fence corner South, East and West (H.H. Brehmer 1943). Found 1 1/2" iron pipe on fence North, East and West (Mitchell 1984).

Witnesses:  
N85°W 6" Scotch Pine 46.88' on slope  
N40°E 8" Scotch Pine 26.35'  
N25°E 3" White Pine 31.2'

Found 1 1/2" iron pipe accepted as the best available evidence of the position of the the original corner by the Leelanau County Remonumentation Peer Review Group on December 16, 1998 and replaced with a 3/4" galvanized iron pipe, 3' long, with a brass cap.

Existing witnesses:	New Witnesses:
10" Scotch pine, N85°W 46.35'	6" Oak, N80°W 26.85'
10" Scotch pine, N40°E, 26.40'	
6" W. Pine, N25°E, 31.60'
