LAND CORNER RECORDATION CERTIFICATE
Filing Requirement of Act 74, Mich. P.A. 1970

Iron <small>(County)</small>	Located In:	Corner Code #
1. Public Land Survey	T 43N R 33W	C3
	T _____ R _____	_____
	T _____ R _____	_____
	T _____ R _____	_____
2. Property Controlling in Section	S 8 T 43N R 33W	3
	S _____ T _____ R _____	_____
3. Miscellaneous Property in Sec.	S _____ T _____ R _____	_____

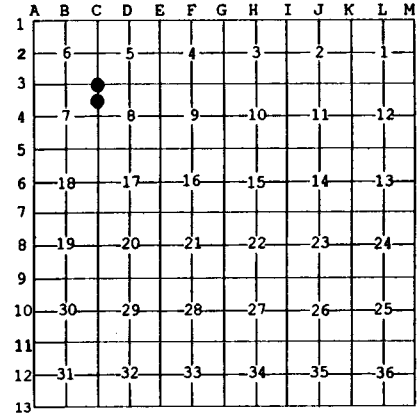
(C3) Recovered the 1973 monument, as described, in good condition, at record bearing and distance from the 1973 witnesses. The 8.Spruce is in good condition, the Elm is a dead stump, 10" dia. with no marks visible, the Balsam is dead but standing. Left the monument in place and made three new witnesses as described below.
 (3-Sec. 8) Recovered the 1974 monument, as described, leaning in rocky ground, at record bearing and distance from the 1974 accessories, both recovered in good condition. Straightened the monument so that it's top is in accord with the record witnesses. Made new markings on the 1974 witnesses and marked two new bearing trees as described below.

(C3) Found 1"ID iron pipe with 4" alum. MDNR cap. Blazed and scribed:	(3) Found 1"ID iron pipe w/3.5" alum. MDNR cap. Blazed and scribed:
6" Balsam N33E 12.6' "S5 NBT"	8" Maple N31E 9.7' "1/16S BT" ('74 wit)
6" Balsam S28E 22.7' "S8 NBT"	5" Maple N16W 9.6' do do
7" W.Birch S30W 15.5' "S7 NBT"	8" Maple S65E 26.1' do
Squared cedar post 2' southerly.	3" Maple S33W 20.9' do
Bearings are magnetic. Distances to notch in lower blaze.	Bearings are magnetic. Distances to notch in lower blaze.
