LAND CORNER RECORDATION CERTIFICATE
Filing Requirement of Act 74, Mich. P.A. 1970

H-5 - 1/4 Corner common to Sections 10 & 15, T19N, R13W, Lake Co., Mi.

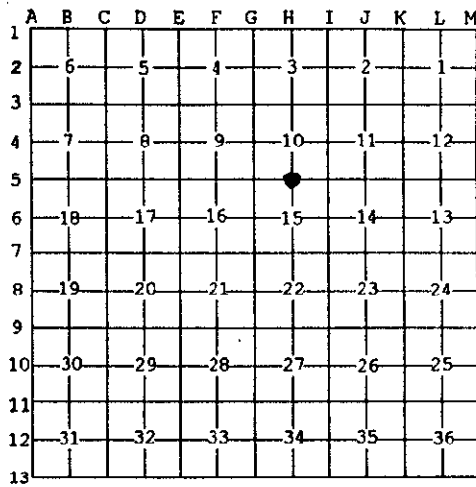
I found Griffin's 5" Square Concrete Monument 1' below surface of blacktop road (raised to surface with railroad spike).

Condition of the accessories are as follows: #1 Gone, #2 Gone, #3 Found Stump, # 4 Found in good condition, #5 Found in good condition, #6 Found in good condition, #7 Found in good condition, #8 Found in good condition.

I accepted the 5" Square Concrete Monument as a substantial marker for the corner, and is accepted as a careful and faithful re-establishment of the position of the original corner.
