LAND CORNER RECORDATION CERTIFICATE
Filing Requirement of Act 74, Mich. P.A. 1970

C-5 - Section corner common to Sections 7, 8, 17 & 18, T20N, R12W, North Newkirk Twp., Lake Co., Mi.

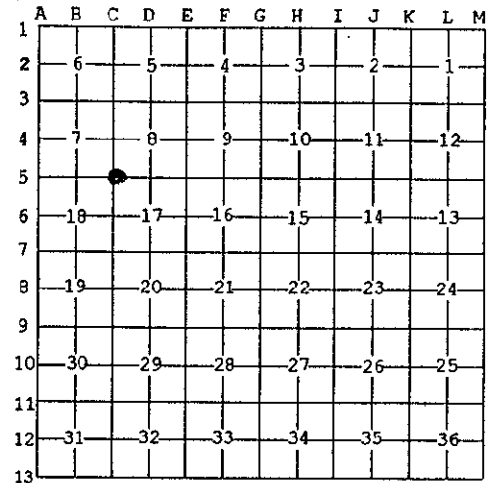
I found old "T" Iron Fence Post in the center of roads East, West, and North and South.
Condition of the accessories are as follows: #1 Gone, #2 Gone, #3 Found in good condition, #4 Found in good condition, #5 Found in good condition, #6 Found in good condition, #7 Found in good condition,

I replaced the Fence Post with a 3/4" x 24" re-bar with Lake County Brass Cap, and is accepted as a careful and faithful re-establishment of the position of the original corner.
