SURVEY & REMONUMENTATION

LAND CORNER RECORDATION CERTIFICATE
Filing Requirement of Act 74, Mich. P.A. 1970

MARQUETTE COUNTY
MICHIGAN
RECEIVED FOR RECORD

a. Description of original monument and accessories and/or subsequent restoration:
1-9; Southwest Corner Section 23;
See back of form.

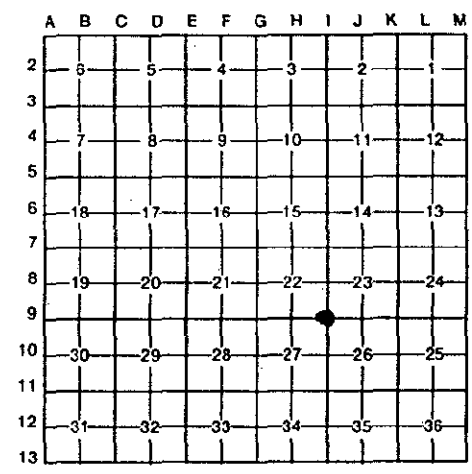
I-9; Southwest Corner Section 23;

Found no evidence of M.C.R.C. monumentation or accessories. Corner was positioned in the following manner after a careful analysis of the U.S. field notes and the M.C.R.C. field notes, traverses, calculations, and intent.

Recovered M.C.R.C. 1" iron pipe monuments at the following corners: northwest corner section 23, west one-quarter corner section 23, west one-quarter corner section 26, and the southwest corner section 26.
