LAND CORNER RECORDATION CERTIFICATE  
Filing Requirement of Act 74, Mich. P.A. 1970

For corners in  
MENOMINEE  
(County)

Located In:	Corner Code #
T <u>35</u> N R <u>28</u> W	<u>105</u>
T___R___	_____
T___R___	_____
T___R___	_____
S___T___R___	_____
S___T___R___	_____
S___T___R___	_____
S___T___R___	_____

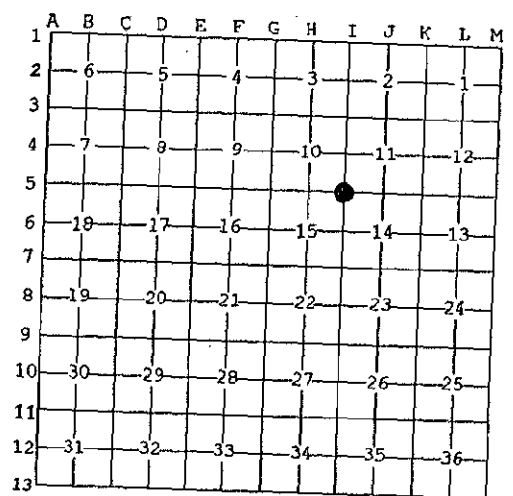
We found a 1" diameter Iron Pipe/4" cap marked "MICHIGAN DEPARTMENT OF CONSERVATION" and 3 B.T.'s as described in part "A" in good condition. The original Cedar stump is in very poor condition and no identifiable marks are visible, however the stump is in the proper position. We accepted the existing monument as a careful and faithful perpetuation of the position of the original corner.

Accepted existing 1" Iron Pipe/4" brass cap marked "MICHIGAN DEPARTMENT OF CONSERVATION" and stamped for corner:

9" dia. Cedar	N03°E	12.07 feet	Scr. NBT
12" dia. Cedar	S90°E	18.05 feet	Scr. NBT
11" dia. Cedar (existing B.T.)	S21°W	7.10 feet	Scr. NBT
6" dia. Cedar	N80°W	12.98 feet	Scr. NBT
