LAND CORNER RECORDATION CERTIFICATE
Filing Requirement of Act 74, Mich. P.A. 1970

| MENOMINEE (County) | Located In: | Corner Code # |
| 1. Public Land Survey | T <u>36N</u> R <u>26W</u> | <u>D01</u> |

SAME AS CORNER D-13 T37N-R26W

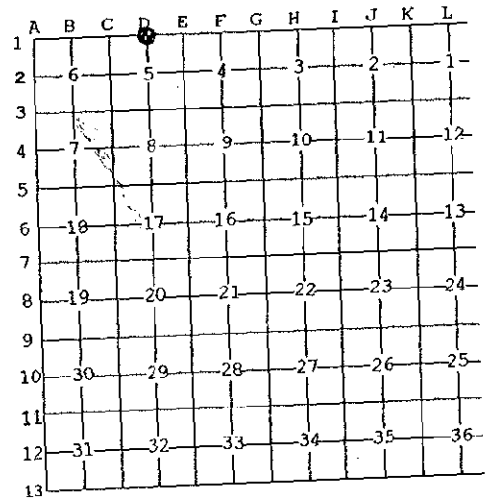
1847: Original Survey (Twp Bdy) by James H. Mullett - B.T.'s - Hemlock, 12" - N60°W - 40 lks; Hemlock, 16" - N30°E - 26 lks. All original evidence for this corner has been destroyed by county road improvements.

We set this corner in the centerline of an East - West County Road and midway between the Northwest Corner (C-1) and the Northeast Corner (E-1) of Section 5. This position fits well with a GLO Terrain call (swamp edge 0.5 chains East) and with long standing lines of occupation, and is accepted as a careful and faithful reestablishment of the position of the original corner. The corner position thus established falls 92 feet West of the centerline of a county road running South.

C. Description of monument for corner and accessories established to perpetuate locating the position of the corner:
Set 5/8" x 24" Iron Rod/3-1/4" dia. Alum. cap stamped for corner location in Monument Box:
