**LAND CORNER RECORDATION CERTIFICATE**  
**Filing Requirement of Act 74, Mich. P.A. 1970**

<u>Roscommon</u> <small>(County)</small>	Located In:	Corner Code #
1. Public Land Survey	T <u>23N</u> R <u>4W</u>	<u>A-9</u>
2. Property Controlling in Section	S <u>    </u> T <u>    </u> R <u>    </u>	<u>    </u>
3. Miscellaneous Property in Sec.	S <u>    </u> T <u>    </u> R <u>    </u>	<u>    </u>

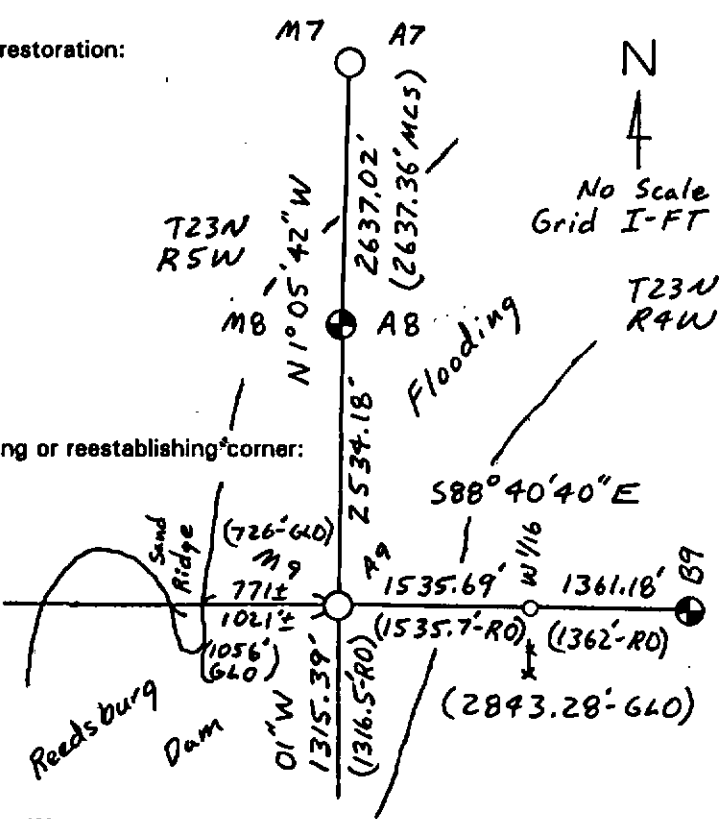
- A-9 - Standard Sec. Corner Common Sec. 19 & 30, T23N, R4W & Sec. 24 & 25, T23N, R5W - Corner Position is underwater in Reedsburg Dam Flooding - 10' + Deep. - Corner Position is calculated by using R. Ostling 1954 Subdivision and monumentation of Sec. 30. See Diagram. Calculated position accepted as the best available evidence of the position of the original corner.

- A-9 - No Monument Set - Falls in Flooding.  
MI State Plane Coordinates - Central Zone  
NAD 83 (1994)  
X = 19557332.95 I-FT  
Y = 382456.90 I-FT  
See Diagram for Wit. Ties.
