LAND CORNER RECORDATION CERTIFICATE  
 Filing Requirement of Act 74, Mich. P.A. 1970

WASHTENAW  
 (County)

Located In: YPSILANTI TOWNSHIP

E-10

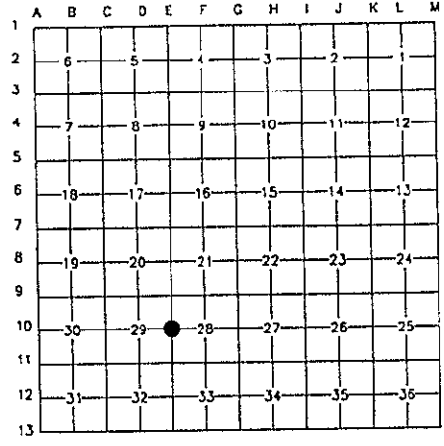
- B. Description of corner evidence and/or method applied in restoring or reestablishing corner:
- E-10 YPSILANTI TOWNSHIP  
 FOUND 1"x18" 2" BELOW GRAVEL SURFACE. DUG FURTHER AND FOUND 3/4"x 24" IRON PIPE IN STONE LEANING SOUTHWESTERLY. DUG FURTHER AND FOUND 1"x 48" IRON PIPE 12" BELOW GRAVEL SURFACE SURROUNDED BY STONE, BRICK AND SOME SORT OF WOOD MATERIAL. DETERMINED THAT THE 1"x 48" IRON PIPE IS THE CORRECT CORNER. SET 1" IRON PIPE AND REMON CAP OVER THE 1"x 48" IRON PIPE.

- C. Description of monument for corner and accessories established to perpetuate locating the position of the corner:
- 1" IRON PIPE WITH ALUMINUM REMONUMENTATION CAP STAMPED #41914

- 12) FOUND 3/4" IRON PIPE N40°W 0.66' INCORRECT CORNER
  - 13) FOUND 1" IRON PIPE WEST 1.00' (DETERMINED TO BE AN INCORRECT CORNER)
