INSTITUTE FOR FISHERIES RESEARCH

REPORT NO. 583

HOUGHTON LAKE NORTHERN PIKE INVESTIGATIONS, 1939

PROGRESS REPORT

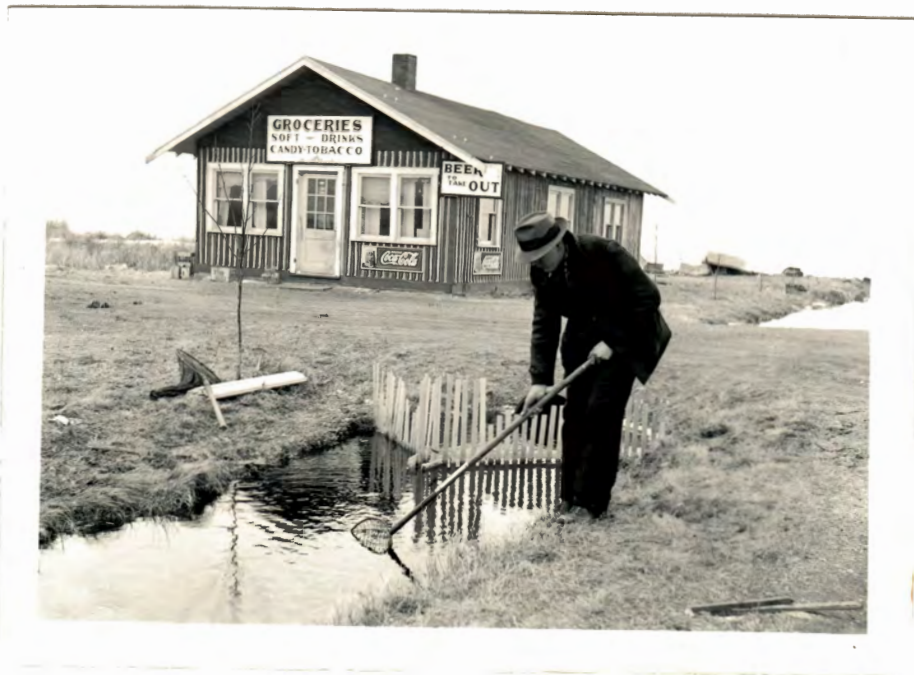
The weir was constructed of four-foot plaster lath and consisted of two wings set in the bank and running to the center of the ditch in the form of a "V."

The lath were driven into the bottom, an inch apart, and braced in the middle and at the top by a 1 x 3 inch board. The small end of the "V" was 3 1/2 inches. The wings of the "V" formed an angle of approximately 45 degrees with the banks. A single wing was installed perpendicular to

each bank and 15 feet from the apex of the "V." This single wing was also constructed of lath driven into the bottom to depths ranging from 6 inches to 2 feet, depending upon the composition of the bottom. Boards 1 x 3 inches were placed in the middle and at the top of the laths to act as braces and spacers. In places where the bottom was still frozen, holes were made by driving a crowbar into the bottom with an axe. The weir was completed by 7:30 p.m. on April 3. Later a trap of similar construction was installed on the ditch to take the fish moving downstream.

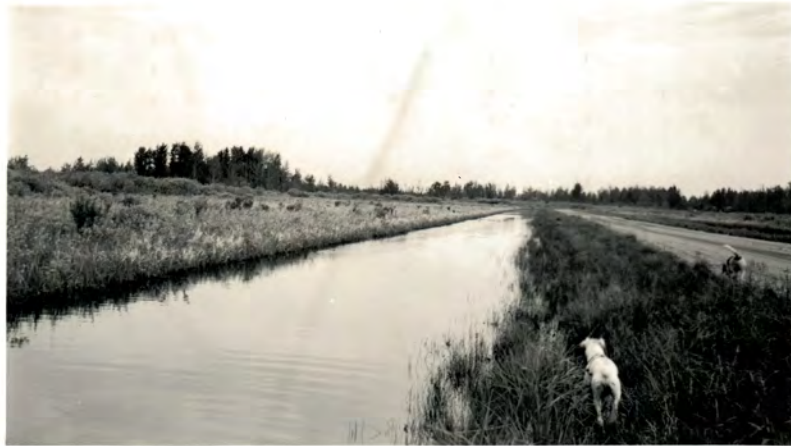
Looking north along Ditch No. 3. Note flooded right bank with dense growth of marsh grass.

3. Ditch III extends in an almost north-south direction for  $1 \frac{1}{4}$  miles from the point where it enters Ditch I. Adult and young pike were found in the lower mile of this ditch.

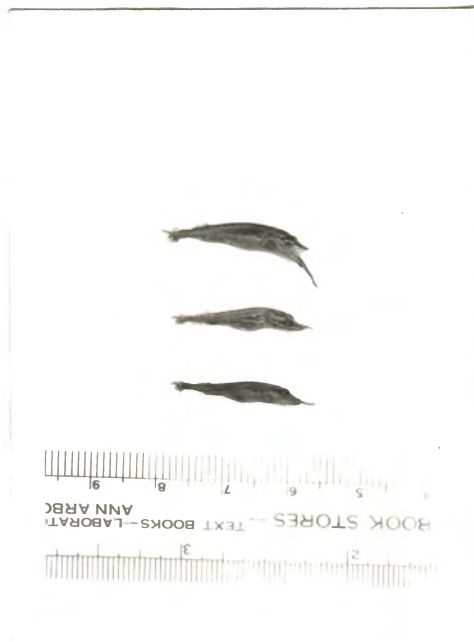
Northern pike fry removed from Peterson's ditch on May 21, 1939. Each pike has tail of another pike projecting from mouth. From the bottom upwards these pike are 21, 22 and 23 mm. in length.

Several days after hatching, fry were observed eating small plankters (zooplankton) in the water. Pike started feeding on one another at a length of 21 mm. ( 13/16 inch) -- See picture. A number of pike fry and fingerlings have been preserved and stomach examinations will be made at a later date.

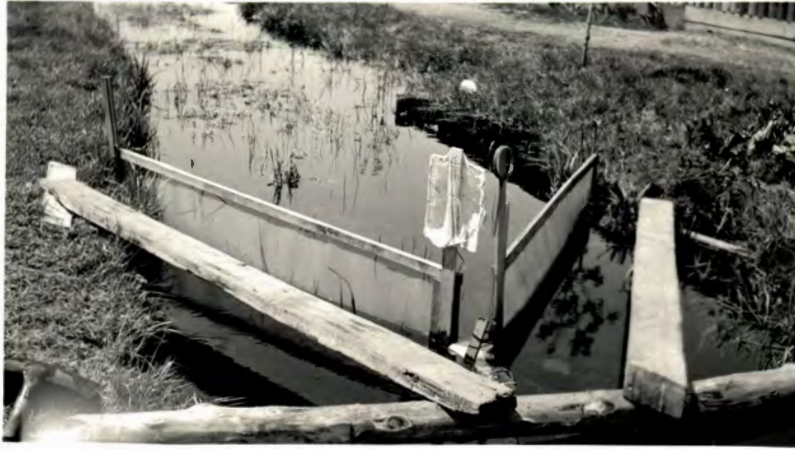
Front view (looking upstream) of pike fry trap on Peterson's ditch. Note vegetation in ditch.

On May 9, several pike fry were observed going through the culvert above Peterson's house in Ditch I. On May 10, six fry were seen in the adult pike weir opposite Peterson's house (100 feet from the lake), and were apparently moving toward the lake. The first fry were observed actually entering the lake on May 12; therefore on this day a fry trap was designed and installed by Mr. Harold Bowditch (see map for location of fry weirs). The trap was constructed by building two frames, each 2 1/2 feet wide and 6 feet long, covered with fine wire screen (see picture). These screens were placed in the ditch, each wing buried securely in one bank, and angling downstream to form a V. The small end of the V was left open. This gap was filled by nailing a large square, tin funnel on each side of each of the two wings. A glass minnow trap was slipped over the small end of the funnel that projected downstream. Later in the season wire minnow traps were substituted for the glass traps. On June 2 the plug was removed from the culvert leading between Ditches I and V. This was done to allow the water to drain from the ditches. At this time the water ceased to flow from the ditches into Houghton Lake because of the barrier of sand and debris that was piled at the mouth of the ditch by the wave action. Fry trap No. 1 was moved to a point approximately 2 miles from Peterson's house (location 2 on map, and now called fry trap No. 2). Fry trap No. 3 was installed on June 12 in Ditch I, next to the culvert joining Ditches I and V.

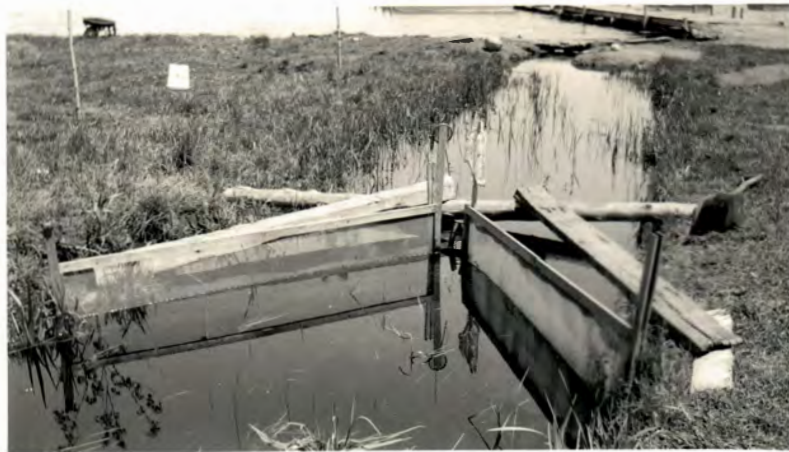
Back view (looking downstream) of pike fry trap on Peterson's ditch. Houghton Lake is in the background.

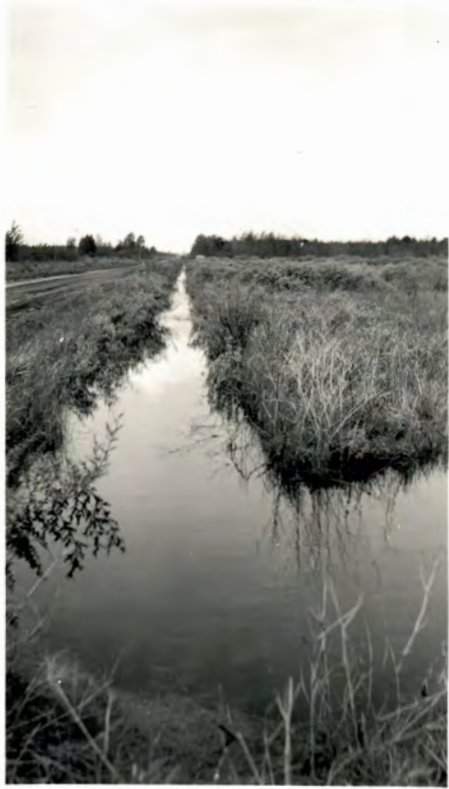
Looking west along Ditch No. 1. Note dense vegetation along ditch banks (leather leaf and marsh grass).

1. Ditch I runs east and west on the north side of the road running directly into North Bay at Peterson's, and is approximately one-quarter of a mile long. This is the main ditch and leads directly into the lake. At the west end it is connected directly to Ditch V by a culvert. This culvert was plugged on April 2 to keep the pike from going into Ditch V.
