LAND CORNER RECORDATION CERTIFICATE
Filing Requirement of Act 74, Mich. P.A. 1970

For corners in
Alger
 (County)

| 1. Public Land Survey | T <u>47N</u> R <u>17W</u> | <u>65</u> |

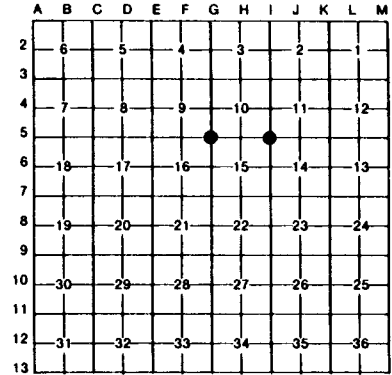
- (65) Corner common to Sections 9-10-15-16. 1956: Reestablished by Billy D. Buckler by double proportionate measurement. 1" iron pipe with 4" brass cap. 12" Hard Maple N31W 33 links. 6" Hard Maple N24E 18 links.
 (15) Corner common to Sections 10-11-14-15. 1956: Corner re-witnessed by Billy D. Buckler. Found 4" square concrete monument with 1/2" steel bar in center. 15" Y.Birch N13E 85 links, 6" B.Cherry S56E 54 links, 7" Hard Maple S45W 77 links.

- (65) Recovered the 1956 monument, a 1" ID iron pipe with a 4" brass MI Dept. of Conservation tablet, in good condition, and at record bearing and distance from the 1956 accessories, both in good condition.
 (15) Recovered a 1/2" rebar encased in a 4"x4" concrete monument, in good condition, and at record bearing and distance from the 1956 NBTs, all in good condition. Accepted the monument as the best available evidence of the position of the original corner.
