LAND CORNER RECORDATION CERTIFICATE
Filing Requirement of Act 74, Mich. P.A. 1970

| 1. Public Land Survey | T <u>47N</u> R <u>17W</u> | <u>C3</u> |

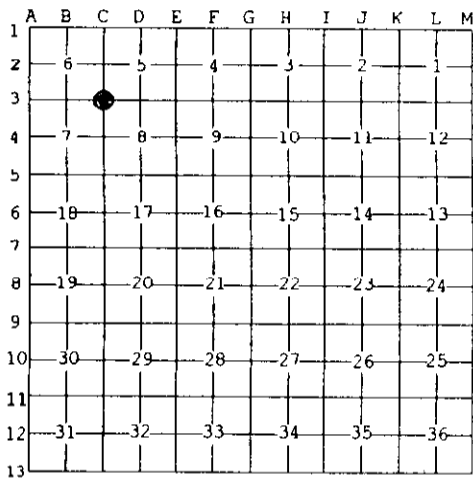
A. Description of original monument and accessories and/or subsequent restoration:
 (C3) Corner common to Sections 5-6-7-8. Reestablished in 1956 by Billy D. Buckler, RLS, using double proportionate measurement. Set 1" iron pipe with 4" brass cap. 12" Hard Maple S28W 38 links, 11" Hard Maple N06E 36.5 links, 8" Hard Maple S81E 31 links.

(C3) The 1956 monument was recovered in good condition S25W 22.8' from the position established in 1956. Judging by marks on the cap and the pipe, and its location with respect to the 1956 witness trees, it had evidently been struck by heavy equipment sometime in the past and had been reinstalled at an erroneous position. Several nearby trees have old overgrown blazes which face the erroneous position. I conclude from a ring count that the blazes were made about 30 years ago. I removed the 1956 monument and reinstalled it at the 1956 position, indicated by a distinct hole found in the forest floor at record bearing and distance from the 1956 witness trees, all recovered in good condition and with overgrown blazes. From the re-monumented position, distances to Quarter corners east and south check with the 1956 survey notes.

(C3) Set 1" ID I. pipe with 4" brass cap. (the 1956 monument). Blazed, scribed, and set measuring nails in:
 12" Sugar N60E 2.45' "S5 N8T"
 The 1956 N8Ts:
 18" Sugar S35W 25.1' "S7"
 18" Sugar N10E 24.2' "S5"
 14" Sugar S74E 20.7' "S8"

Bearings are magnetic. Distances are to nail with tag. Set a cedar post adjacent.
