LAND CORNER RECORDATION CERTIFICATE
Filing Requirement of Act 74, Mich. P.A. 1970

(County)	Located In:	Corner Code #
1. Public Land Survey	T <u>49N</u> R <u>13W</u>	<u>68</u>
	T _____ R _____	_____
	T _____ R _____	_____
	T _____ R _____	_____
2. Property Controlling in Section	S _____ T _____ R _____	_____
	S _____ T _____ R _____	_____
3. Miscellaneous Property in Sec.	S _____ T _____ R _____	_____
	S _____ T _____ R _____	_____

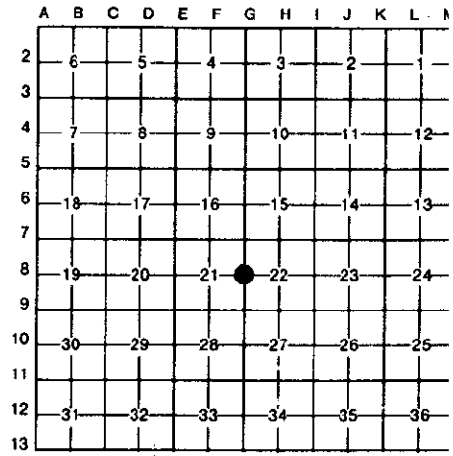
B. Description of corner evidence found and/or method applied in restoring or reestablishing corner:
G8: A search was made for 4" post and iron at corner position. Iron and post have been lost to road maintenance. Established corner position by field survey. Found 1 1/2" iron bar at North 1/16 corner and 1 5/8" axle shaft at South 1/16 corner between sections 21 and 22. Measured from BT section corner southerly to North 1/16 corner and extended line southerly of North 1/16 the measured distance to set the corner position of G8. Measurement from the corner position to the South 1/16 corner agrees well with the measurements north of corner position. Corner position falls on the west side of north-south dirt road. Found old blaze line to the east from the corner position. A search was made at GLO bearing tree positions, evidence has been lost. Corner position is accepted as a careful and faithful reestablishment of the position of the original corner.

C. Description of monument for corner and accessories established to perpetuate locating the position of the corner:
G8: Set Berntsen Mon. no. A1NB30, stamped to identify corner position. Established the following reference trees w/ BT signs, blazed, scribed and painted. Set PK nails for measure w/ Alum. I.D. washers in the following reference trees. Maple 6", S.65 E., 64.26 feet, 1/4s BT ", Maple 14", N.41 E., 92.33 feet, 1/4s BT ", Maple 12", S.62 W., 23.07 feet, 1/4s BT ", Maple 12", N.19 1/2 W., 39.37 feet, 1/4s BT ", Survey Marker sign on six foot steel post, S.75 W., 1.1 feet. All bearings are magnetic.
