ALLEGAN COUNTY REMONUMENTATION
LAND CORNER RECORDATION CERTIFICATE
Filing Requirement of Act 74, Mich. P.A. 1970

ALLEGAN (County)	Located In:	Corner Code #:
1. Public Land Survey	T-3N R-13W T _____ R _____ T _____ R _____ T _____ R _____	H-3 S 1/4 SEC-3 Monterey Twp.
2. Property Controlling in Section	S _____ T _____ R _____ S _____ T _____ R _____	
3. Miscellaneous Property in Sec.	S _____ T _____ R _____ S _____ T _____ R _____

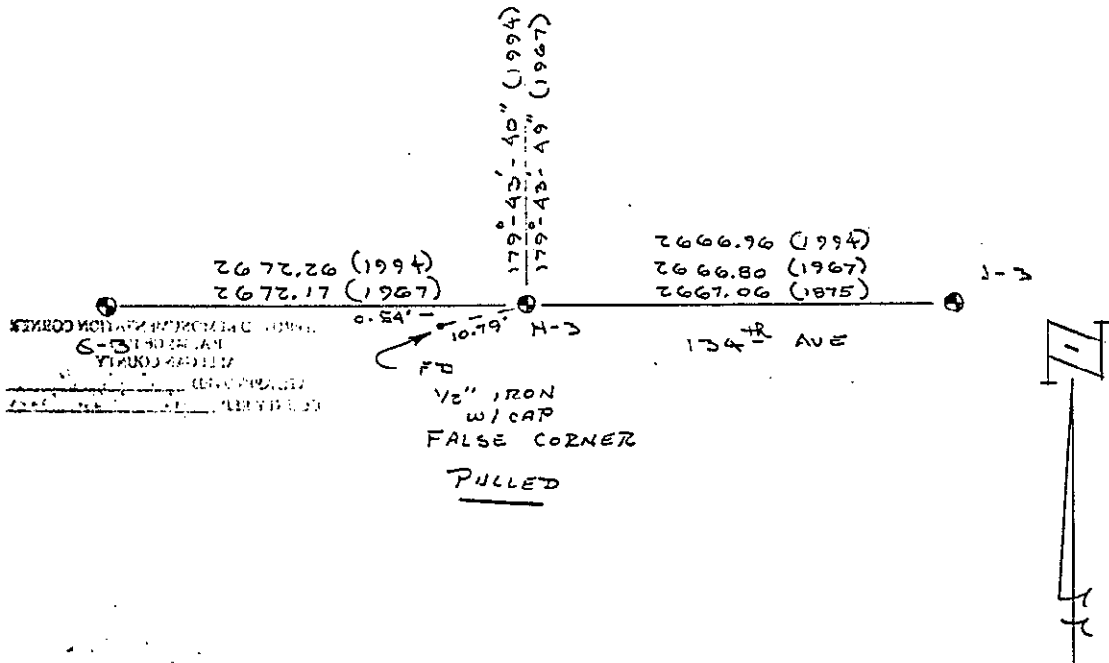
1971 & 1972 SURVEYS BY RATEKIN SHOWING WITNESSES TO FALSE CORNER.
1992 SURVEY BY K.L. VAN ORDER, C.S. USING FALSE CORNER.

NOTE: IN 1967 D.A. RATEKIN, C.S. FOUND AND USED THE CORRECT CORNER IN A SECTION
BREAKDOWN TO STAKE A CONSUMERS POWER FEE STRIP.
SUBSEQUENTLY, IN 1971 AN ERRONEOUS CORNER WAS FOUND AND RECORDED IN THE
ABOVE MENTIONED L.C.R.C.
THIS IS DUE PARTLY IN FACT, BECAUSE THE 1967 WITNESSES WERE DESTROYED AND
THE FALSE CORNER IS IN LINE WITH A 2-TRACK TO THE NORTH.
