LAND CORNER RECORDATION CERTIFICATE

For Corners In: <u>Arenac</u> (County)	Located In _____	Corner Code # _____
1. Public Land Survey	T <u>19N</u> R <u>3E</u>	<u>G7</u>
	T _____ R _____	_____
2. Property Controlling in Section	S _____ T _____ R _____	_____
	S _____ T _____ R _____	_____
3. Miscellaneous Property in Section	S _____ T _____ R _____	_____
	S _____ T _____ R _____	_____
4. Lot No: _____	Recorded Plat: _____	
5. Private Claims: _____

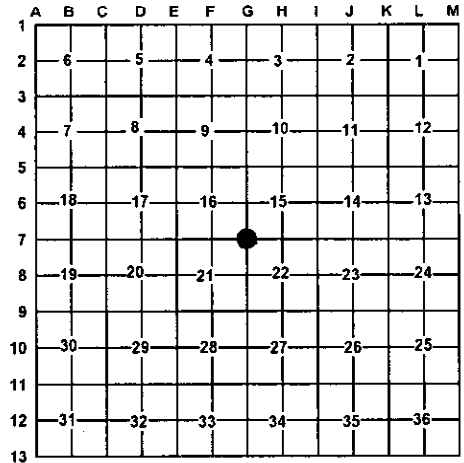
- G7 – Sec. Cor. Common to Sec. 15, 16, 21 & 22 – No GLO evidence. All CSR BT's are gone. Used 1911 Co. Sur. record notes to re-establish corner as follows: Found 1911 corner at 'G6' and re-established 1911 'G5' position (not used as 'G5') from OBT and 33' N. of 1914 Lucas 'G5' position (accepted corner) as noted by Lucas. 'G6' was established midway and on line between 'G7' and 'G5' in 1911. Thus extend line from 1911 'G5' through 'G6' to control longitudinal position for 'G7'. Latitude for 'G7' per 1911 notes as follows: S 2641.03' – M. vs. 2640' – R. (1911) to 'G8' and N. 2641.03' – M. vs. 2640' – R. (1911) to 'G6'. Dug at this position but dry sand only. Thus set 4" DNR Alum. Cap on 1" x 36" galv. iron pipe at 1911 position as calculated. Centerline of E-W Gravel Rd. is 54' S. DNR Mon. accepted as the best available evidence of the position of the original corner.

- Ref. Pt. -- Fd. 1 ½" O. D. iron pipe in Centerline of Gravel Rd. 'T' intersection is S12°01'E 54.39' of 'G7'. This appears to be 1921 Rd. survey corner. A distance blunder appears to have been made when measuring N. from 'G8'. From the 1 ½" pipe south measured 2587.7' vs. 2639.34' - R. (1921) to 'G8' in centerline 'T' intersection. No other logical position for 'G8'. Measured N. from 1 ½" pipe 2694.42' vs. 2694.12' – R. (1921) to fd. 1911 'G6'. Though roads were built to 1921 position S, E & W couldn't accept 1 1/2 " pipe as proper position for 'G7'. 1 ½" pipe not utilized as 'G7' in this survey.

- G7 – 4" DNR Alum. Cap on 1" x 36" galv. iron pipe
 - Set Blue Carsonite Post 1' N.
 - S3° 32'W 143.32' to USGS BM "12 WMC"
 - N23°E 34.44' to set N & T in SE side 24" Oak scribed 'XBT'
 - N78°W 65.85' to set N & T in NE side Tw. 16" and 22" Oak scribed 'XBT'
 - S61°W 28.12' to set N & T in SE side Tri. 24" Oak
 - S30°E 120.73' to set N & T in P.P.
 - S12°01' E. 54.39' to Fd. 1 ½" pipe – Ref. Pt.
