LAND CORNER RECORDATION CERTIFICATE

Filing Requirement of Act 74, Mich. PA 1970

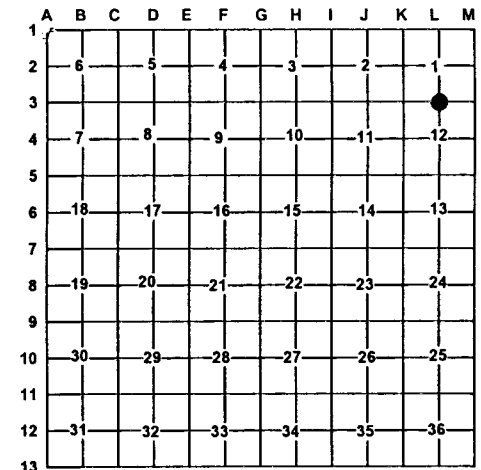
- A. Description of original monument and accessories and/or subsequent restoration:
- L3 - GLO - Set 1/4 post - J. Burt - 1843
 - S. Pine 10" N55°E 25 L.
 - Y. Pine 22" S82°W 30 L.
 - CSR - Lg. Bk., P. 37 - G.F. Carscallen - 1900
 - Sec. 12 Survey. One Witness found.
 - CSR - FB. 1, P.34- 1910 - Fd. ogl. Wit. & old rotten oak post
 - B. Oak 10" N47°E 66 L.
 - B. Oak 8" N54 1/2°W 55 L.
 - MDOT - 1957 - Fd. 4" x 4" wood stake
 - Set 1" axle, 8" Oak N75°W 18.64'; 12" Oak N5°E 14.82';
 - 9" Oak S50°E 12.25'
 - Rec. Sur. - L.2, P.133 & 150 - Fd. 1" axle shaft - 1996

L3 - 1/4 corner common to Sec. 1 & 12 - Fd. 1" x 2.4" axle shaft per MDOT notes & Rec. Survey leaning - we straighten. Centerline of E-W Sand Rd. is 55' S. Fit Co. Survey distance E & W proportionally being 6'+/- longer than Co. record of 1910. GLO & CSR BT's are gone. Appears that MDOT recovered perpetuated original corner position. 1" axle accepted as a careful & faithful perpetuation of the position of the original corner.

L3 - Replaced 1" x 2.4' axle shaft with 4" DOC (DNR) alum. cap on 1" x 4' Galv. Iron pipe. Set Blue Carsonite Post 1' NE
 Reset steel fence post 1' W
 S59°E 12.52' to set N & T in S side 24" Oak scribed 'XBT' (MDOT)
 S81°W 10.76' to set N & T in S side 7" Oak scribed 'XBT'
 N58°E 66.69' to set N & T in SE side 15" W. Pine scribed 'XBT'
 N8°E 16.08' to set N & T in W side 5" Oak
