LAND CORNER RECORDATION CERTIFICATE
Filing Requirement of Act 74, Mich. P.A. 1970

For corners in
Baraga

(County)	Located In:	Corner Code \neq f
1. Public Land Survey	T <u>48N</u> R <u>32W</u>	<u>D9</u>
	T _____ R _____	_____
	T _____ R _____	_____
	T _____ R _____	_____
2. Property Controlling in Section	S <u>20</u> T <u>48N</u> R <u>32W</u>	<u>3</u>
	S <u>20</u> T <u>48N</u> R <u>32W</u>	<u>9</u>
3. Miscellaneous Property in Sec.	S _____ T _____ R _____	_____
	S _____ T _____ R _____	_____

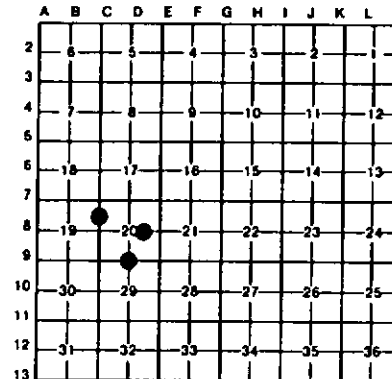
(D9) Quarter corner common to Sections 20-29. Corner established in 1852 by Guy H. Carleton. Original post referenced by the following bearing trees: Sugar 12 S35E 43 links, Sugar 10 N40W 82 links. Found no subsequent record.
 (3-Sec. 20) North 1/16 corner between Sections 19-20. Corner not established in the original survey. Found no subsequent record.
 (9-Sec. 20) East 1/16 corner of Section 20. Corner not established in the original survey. Found no subsequent record.

(D9) Original post and accessories not recovered. Found no acceptable evidence of the position of the original corner. Reestablished the corner midway and on a straight line between Section corners 2647.55' east and west, being the proportionate position. At the position for the corner, I placed a 1" I.D. x32" iron pipe capped with a 4" dia. cast aluminum MDNR tablet.
 (3-Sec. 20) Found no evidence of prior monumentation. Established the corner midway and on a straight line between section corner 1312.76' north and quarter corner 1312.76' south. At the position for the corner, I placed a 1" I.D. x32" iron pipe capped with a 4" dia. cast aluminum MDNR tablet.
 (9-Sec. 20) Found no evidence of prior monumentation. Established the corner midway and on a straight line between the 1/4 corner common to Section 20-21, and the center of section 20 (non-monumented intersection of 1/4 lines). At the position for the corner, I placed a 1" I.D. x32" iron pipe capped with a 4" dia. cast aluminum MDNR tablet.

(D9) Set 1" pipe with 4" aluminum cap. Blazed and scribed the following new bearing trees: 24" W. Pine S88W 3.2' "1/4S NBT" 12" W. Pine S01W 41.1' "1/4S NBT" 12" Maple S62E 18.0' "1/4S NBT" 18" W. Pine N33W 50.1' "1/4S NBT" Placed a 3" squared maple post 1' north.	(3) Set 1" pipe with 4" aluminum cap. Blazed and scribed the following bearing trees: 6" Spruce N75E 21.2' "1/16S BT" 7" Spruce S05E 53.5' "1/16S BT" 14" Tamarack S60W 35.6' "1/16S BT" 5" Spruce N33W 19.7' "1/16S BT" Placed a squared spruce post 1 ft. north of the corner.	(9) Set 1" pipe with 4" aluminum cap. Blazed and scribed the following bearing trees: 12" W. Pine S78E 35.3' "1/16S BT" 4" Balsam N30E 6.0' "1/16S BT" 9" Cedar N58W 44.4' "1/16S BT" 12" W. Pine S22W 27.45' "1/16S BT" Placed a 3" squared cedar post 1' south.
--	--	---
