LAND CORNER RECORDATION CERTIFICATE
Filing Requirement of Act 74, Mich. P.A. 1970

<u>Baraga</u>	Located In:	Corner Code #	
<small>(County)</small>			
1. Public Land Survey	T <u>53N</u> R <u>30W</u>	<u>B11</u>	_____
	T _____ R _____	_____	_____
	T _____ R _____	_____	_____
	T _____ R _____	_____	_____
2. Property Controlling in Section	S <u>31</u> T <u>53N</u> R <u>30W</u>	<u>2</u>	_____
	S _____ T _____ R _____	_____	_____
3. Miscellaneous Property in Sec.	S _____ T _____ R _____	_____	_____
	S _____ T _____ R _____	_____	_____

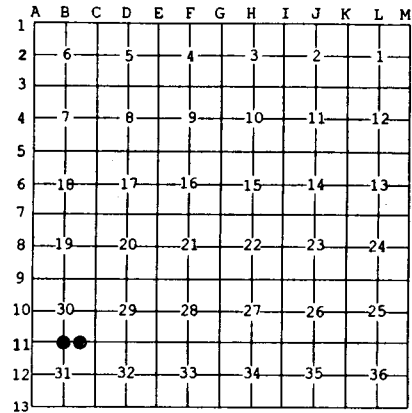
A. Description of original monument and accessories and/or subsequent restoration:
 (B11) Quarter corner common to Sections 30-31. Established in 1846 by Wm. Ives: East between Section 30 & 31...40.00 Set qr. Section post Y.Birch 30 S37W 10, Sugar 10 N48E 30...67.45 W.Pine 24....80.00 Set post corner of Secs 29-30-31-32.
 (2-Sec. 31) East 1/16 corner between Sections 30-31. Not established in the original survey.

(B11) The original post and accessories were not recovered. Recovered the remains of the line tree W.Pine 24, now a 34" dia. 3.5' tall rotting stump with no markings visible, 67.4529 chains east of the original section corner A11. Reestablished the Quarter corner B11 by single proportionate measurement to the original record between the Section corner and the line tree.
 (2-Sec. 31) Established the corner midway and on a line of mean true bearing between Quarter corner 1320.04' west and Section corner 1320.04 east.

(B11) Set 1"IDx32" I.pipe with 4" alum. MDNR cap. Blazed and scribed:	(2).Set 1"IDx32" I.pipe with 4" alum. MDNR cap. Blazed and scribed:
10" Sugar N46E 12.8' "1/4S NBT"	10" Cedar N82E 9.8' "1/16S BT"
5" Sugar N83E 26.5' do	12" Hemlock S22E 24.9' do
10" Sugar S24W 17.4' do	14" Cedar S11W 35.3' do
6" Sugar N60W 40.6' do	5" Sugar N77W 5.3' do
Set squared cedar post adjacent.	Set two squared cedar posts adjacent.
Bearings are magnetic. Distances are to notch in lower blaze.	Bearings are magnetic. Distances are to notch in lower blaze.
