## Bay County Remonumentation

### LAND CORNER RECORDATION CERTIFICATE Filing Requirement of Act 74, Mich. P.A. 1970

Bay (County)	Located In:	Corner Code #
1. Public Land Survey	T <u>14N.</u> R <u>.5E</u>	<u>D 3</u>
	T _____ R _____	_____
	T _____ R _____	_____
	T _____ R _____	_____
2. Property Controlling in Section	S _____ T _____ R _____	_____
	S _____ T _____ R _____	_____
3. Miscellaneous Property in Sec.	S _____ T _____ R _____	_____
	S _____ T _____ R _____	_____
4. Lot No. _____, Recorded Plat _____		
5. Private Claims _____

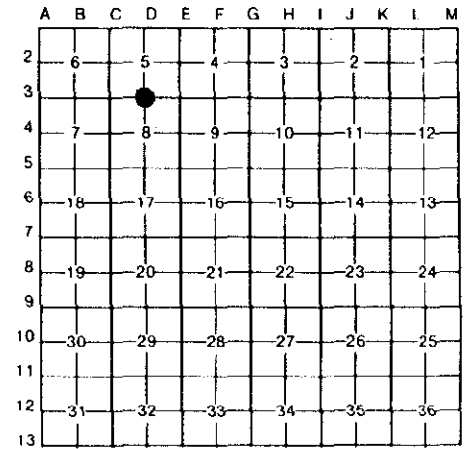
D 3 Set 2-3/4" Bay County brass cap on 5/8" x 24" rebar in mon. box over concrete box culvert.  
N 38° E 32.00' (M & BCRC) (32.02' - Spicer) (31.50' - R) to centerline stem F.H.  
N 30° W 101.70' (M, CPC, BCRC & R) (101.75' - Spicer) to SE. corner stone block foundation House #3737.  
S 35° E 25.43' to NE. corner concrete headwall.  
S 74° W 117.95' to nail and tag in U.P.  
S 35° E 42.68' to nail and tag in E. side U.P.

D 3 Set remon. position per witnesses from house corner and fire hydrant per C.P.Co survey, Spicer notes and BCRC witnesses. Position falls 0.4' N. of centerline mon. box (no iron) that was incorrectly placed after reconstruction of the box culvert for Reichle Drain in late 1970's. Monument accepted as the best available evidence of the position of the original corner.
