## Bay County Remonumentation

### LAND CORNER RECORDATION CERTIFICATE Filing Requirement of Act 74, Mich. P.A. 1970

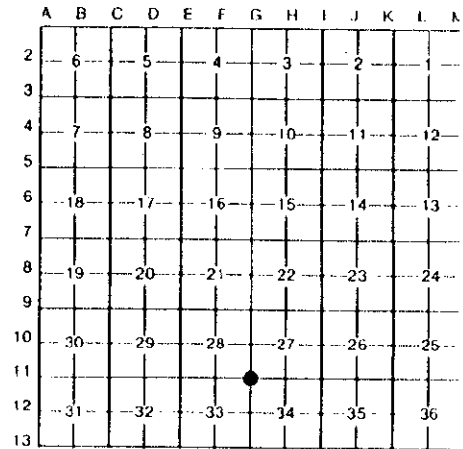
Bay (County)	Located In:	Corner Code #7
1. Public Land Survey	T 15N R 3E	G 11
	T R	
	T R	
	T R	
2. Property Controlling in Section	S T R	
	S T R	
3. Miscellaneous Property in Sec.	S T R	
	S T R	
4. Lot No. _____, Recorded Plat _____		
5. Private Claims _____

**G 11** - Found 1/2" rebar inside 3/4" iron pipe in concrete in broken mon. box per recorded surveys and LCRCs. Remove mon. box, pipe and rebar. Found 4 metal braces 0.5' each side of irons. Found recorded witness as follows:  
N 45° W (R) 55.70' (55.8 -R) to SE. corner of block foundation of Willard Hilton. Monument accepted as the best available evidence of the position of the original corner. Accepted by Bay County Peer Review Group on 8-4-94.

**G 11** Replace 1/2" rebar, 3/4" iron pipe, braces and broken mon. box with 2-3/4" Bay County brass cap on 5/8" x 24" rebar in mon. box.  
N 45°W 55.70' to SE corner block foundation Willard Hilton.  
N 80° E 116.73' to nail and tag in N. side U.P.  
S 12° E 79.64' to nail and tag in W. side U.P.  
S 54°W 44.85' to nail and tag in SE. side U.P.
