LAND CORNER RECORDATION CERTIFICATE

For Corners In:	Located In	Corner Code #
BENZIE (County)		
1. Public Land Survey	T 25N R 14W	1-12
2. Property Controlling in Section	S T R	
3. Miscellaneous Property in Section	S T R

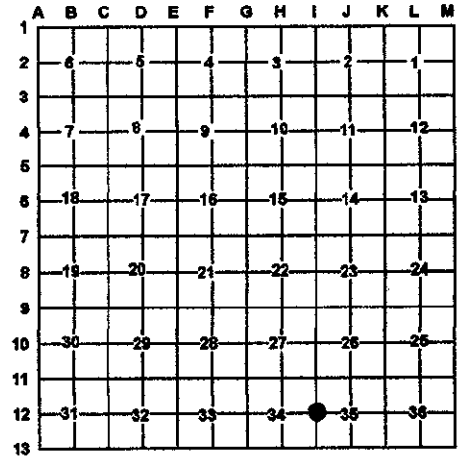
1838: GLO set post and witnesses - 10" Hemlock S59°W 16 links and 12" Sugar N70°E 28 links. 1974: (North Iron) BCRC found a 1" iron pipe with rocks around it - 2' below grade. The asphalt had not been dug up. They raised this to the surface with a 5/8" rod. 1977: (South iron) BCRC found a 1 1/4" iron in original top soil, 2' below existing grade and raised to the surface with a 3/4" iron pipe. No other historical records of any surveys done in this area or using these irons have been found.

1999: At the BCRC North iron, Found a 5/8" X 20" iron over a 5/8" iron pipe 36" below grade. Found large piece of metal and stones around base of iron along with pieces of ceramic and glass. At the BCRC South found a 3/4" X 12" rolled iron pipe with a fitting over a 1/2" iron pipe 24" below grade. This iron was on the south side of a stone pile which was 32" below grade. The stone pile had remains of charcoal and possibly a hole in center of stones for wood stake. Checking measurements to the adjacent section corners showed that the north iron was set close to a MOL position. The south iron was within 2 minutes of a straight line from the East 1/4 corner through the Center of Section. There was no other evidence available, occupations, etc. which would support either position. The north iron had not been dug up and used by any surveyors in the area. The south iron had been dug up and used by surveyors in the area. The fact that the center of section was almost on a straight line between the south iron and the East 1/4 corner helped the Benzie County Peer Group accepted the position of the South iron pipe as the best evidence of a locally accepted corner.
