LAND CORNER RECORDATION CERTIFICATE
Filing Requirement of Act 74, Mich. P.A. 1970

- F-7 - GLO - Maple 10" dia. - 1/4 Cor. - Alvin & Austin Burt - 1839
Hemlock 12" N5°W 39 L.
- Co. Bk., P. 8 - C.P. Tuller - 1900
Found the stump of the Maple corner and the stump of the Hemlock witness.
- Co. Bk., Pg. 22 - C.P. Tuller - 1903
Retraced S. line of Sec. 15 & 16
No mention of S 1/4 Post, Sec. 16
-LCRC - L. 1, P. 312 - R.M. Harris - 1994
Conc. Monument & steel post set
(Proportionate to GLO)
Tw. 16" Oaks S36°W 54.59'
6" Maple N7°E 4.01'
6" W. Pine S78°W 75.14'
14" Maple S37°E 48.84'
43' North of Two Track Road

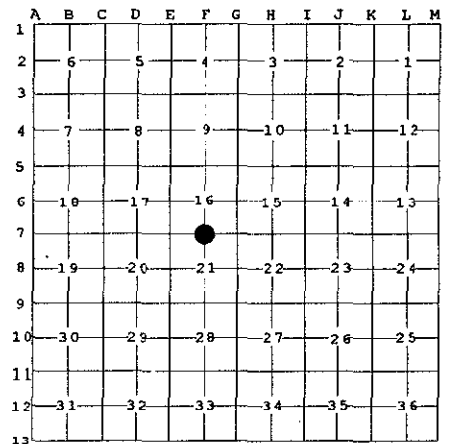
F-7 - 1/4 Corner common to Sec.'s 16&21, T26N,R13W. - FND. 4" Cyl. Conc. Mon. w/ Plastic PS Cap # 25845 per RMH
LCRC - L. 1, P. 312. FND. fence post on ground in hole 2'± SW'ly. Could find no evidence of corner tree per Tuller's 1900 survey. Tuller's 1903 survey done to establish the SE Cor. of Sec. 16 & the S 1/4 Cor. of Sec. 15 - makes no mention of S 1/4 Cor. of Sec. 16, but used SW Cor. of Sec. 16 to prorate 2 miles to the East. Accept Conc. Mon. as a careful & faithful re-establishment of the position of the original corner.

F-7 - Replaced capped 4" x 2.5' long conc. mon. with 3" 'Benzie Co. Remon.' Brass Cap on 3/4" x 36" iron pipe-encased in 4" x 36" concrete cylinder
*S30W 54.56' to set N&T in NW. Side 16" Twin R. Oak
*N2°E 3.99' to set N&T in E. Side 5" R. Maple
*S74°W 75.12' to set N&T in N. Side 7" W. Pine
*S40°E 49.88' to set N&T in SW. Side 12" S. Maple
N54°E 118.43' to set N&T in NW. Side 4" W. Pine
Set Blue Carsonite post 1' N.
Reset steel fence post 1' S.
