Berrien County Remonumentation Program  
LAND CORNER RECORDATION CERTIFICATE SECTION

10-27-98 Filing Requirement of Act 74, Mich. P.A. 1970  
For corners in S1/4 Post Sect. 19 New Buffalo Twp.

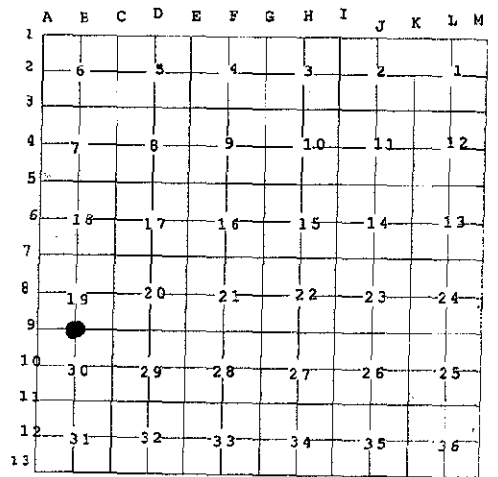
The Berrien County Peer Group authorized me to hold the Indiana line between these two monuments and set our corner at the intersection of this Line and the split of the bearing between the East and West Section lines of Section 19-8-20.

This we did. At that point is the root of a 20" twin tree so I couldn't set a concrete monument.

Placed 1" x 30" Iron pipe with Berrien County Brass Cap (marked 28435 "+" 1998) in root of 20" twin tree and "survey marker" nearby. This position was not established by original government surveyors. This monument is accepted as the best available evidence of the position of the corner.

Witnesses:  
NW corner Sect 8-38-2 (Indiana) West 359.47'  
N 1/4 Post Sec 8-38-2 (Indiana) East ~~2245.42~~ 2246.25'  
N 1/4 Post Sect 19-8-20 North 3722.32'  
Wire fence runs North from corner  
Nail with washer in 24" Oak N58E 11.27'  
Nail with washer in 16" Tree N20E 22.79'  
Nail with washer in 16" Tree S64W 16.64'  
PK in tie of miniature Railroad South 36.51'
