COMMISSIONER BRANCH COUNTY REMONUMENTATION CORNER
LAND CORNER RECORDATION CERTIFICATE
Filing Requirement of Act 74, Mich. P.A. 1970

BRANCH (County)	Located In:	Corner Code #
1. Public Land Survey	T <u>7</u> S R <u>6</u> W	<u>C - 2</u>
	T _____ R _____	_____
	T _____ R _____	_____
	T _____ R _____	_____
2. Property Controlling in Section	S _____ T _____ R _____	_____
	S _____ T _____ R _____	_____
3. Miscellaneous Property in Sec.	S _____ T _____ R _____	_____
	S _____ T _____ R _____	_____

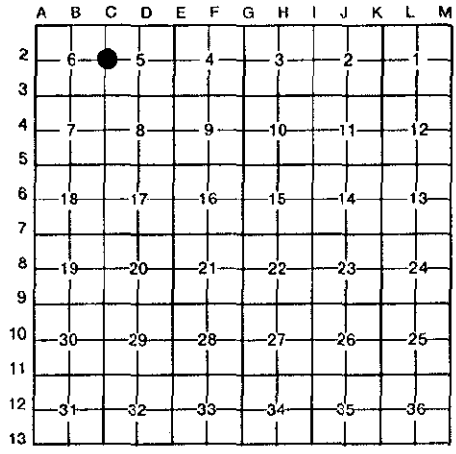
Dug in center of highway over large (6' x 6') area, but could not find stone as noted above.
I found numerous pieces of china or pottery in a small pile at a depth of 22" which is below the road gravel and in a dark soil area surrounded by light sand soil.
I accepted this evidence and reestablished this corner at the location marked by the china (pottery) since this location also fits the proportioned distance for the quarter section line, between the south line of the section and a fenceline marking the occupied north 1/16 line of Section 6 for more that 39 years.
Set a $\frac{1}{2}$ " x 18" rebar iron rod with I.D. cap #7437 in monument box at this location.

$\frac{1}{2}$ " x 18" rebar iron rod with I.D. cap #7437, over stone, in monument box.:
