LAND CORNER RECORDATION CERTIFICATE
Filing Requirement of Act 74, Mich. P.A. 1970 as Amended

<u>Chippewa</u> (County)	Located In:	Corner Code #
1. Public Land Survey	T <u>42N</u> R <u>2E</u>	<u>A3</u>
	T _____ R _____	_____
	T _____ R _____	_____
2. Property Controlling in Section	S _____ T _____ R _____	_____
	S _____ T _____ R _____	_____
3. Miscellaneous Property in Sec.	S _____ T _____ R _____	_____
	S _____ T _____ R _____	_____

(A3) Corner common to Sections 6-7 T42N-R02E and Sections 1-12, T42N-R01E. 1840 - Established by Austin Burt, Deputy Surveyor: South on East side of Section 1 ...80.00 Set post corner of Sections 1 & 12 Cedar 20 S20W 11 links, Cedar 20 N10W 11 links. ...South on East side of Section 12 ...80.00 Fir 4 corner of Section 12 & 13. 1987 - LCRC filed by Wm. L. Karr PS in C-245 Mackinac County Records states "Found no evidence of original corner. Found cedar post. Accepted corner position as found. Corner is a cedar post". Ties: 8" Cedar S52E 38.54', 12" Spruce S24W 24.95', 10" Cedar N25W 37.58', 14" Cedar N23E 47.18'.

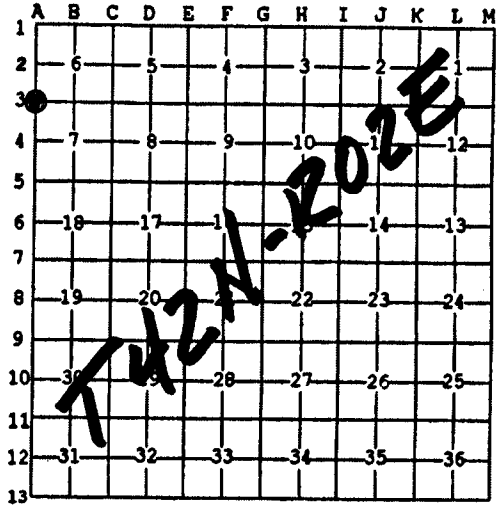
(A3) Set 1" IDx36" I.pipe with 4" alum. MDNR cap. Set measuring nails in:
 9" Cedar N68W 8.65' mrkd "S1 NBT"
 17" Cedar S60W 11.7' mrkd "S12 NBT"
 12" W.Birch S10E 12.6' mrkd "S7 NBT"
 8" Cedar S72E 14.85' mrkd "S7 NBT"
 Bearings are magnetic. Distances are to nail with tag.

(A3) The original post and accessories were not recovered. Recovered a 1" o.d. iron pipe with plastic cap "MLK 27450" conforming to the 1987 record. Continued examination of the position of this monument revealed that it is located approximately N3W (true) 130' from the proportionate position of record which was subsequently monumented by the undersigned. Discussion with Mr. Karr led to the mutual judgement that the 1987 monument of record did not best represent the position of the original corner and it was decided to reestablish the corner by proportionate measurement to the original record. Accordingly, the corner was reestablished on a straight line between monumented Quarter corner A2 2637.87' north and monumented Section corner A5 5275.74' south. The pipe and post marking the 1987 position were removed.
