LAND CORNER RECORDATION CERTIFICATE
Filing Requirement of Act 74, Mich. P.A. 1970

For corners in
 Chippewa
 County

Located In:	Corner Code #/
1. Public Land Survey	T 43N R 2E	D11
	T 43N R 2E	D7
	T R	
	T R	
2. Property Controlling in Section	S 20 T 43N R 2E	7
	S T R	
3. Miscellaneous Property in Sec.	S T R	
	S T R

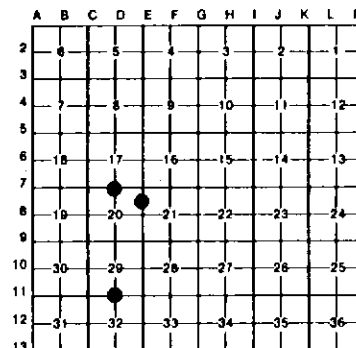
(D11) Corner established by John Mullett, 1845. Accessories: Fir 10 N32W 20, Birch 9 S67W 16. Corner recorded by Ostling (LCRC rec. L. 1 P. 79, Chippewa County Records) in 1973 as set 1/2" iron at government distance east of SW corner of section 29 T43N-R2E and in centerline of old grade.
 (D7) Corner established by John Mullett, 1845. Accessories: Sugar 12 N17E 22, do 10 S17W 10. Found no subsequent record.
 (7) Corner not established in original survey. Found no subsequent record.

(D11) Original post and accessories not recovered. From the pattern of cultural improvements along the south line of section 29, I conclude that the original corner was established on a random line east from the SW corner of section 29 and not midway on the corrected line between section corners as stated in the Government notes. Evidence of a similar situation also exists in regard to the South 1/4 corner of Section 20, T43N-R2E. The improvements noted consist of: an old road grade, old E-W fence lines both north and south of the section line, and an old bridge abutment over the East Branch of the Munuscong River. These improvements appear on aerial photos dated 1939. The photos show the NW 1/4 of section 29 to be subdivided with fences and/or brushlines along the 1/16th lines. I reestablished the corner midway between the old E-W fence lines, in the center of the extension of the old grade, and at the same distance east of the west N-S 1/16 line fence as said fence is east of the SW corner of section 29 (C11 recorded by Ostling in 1973).

(D7) Original post and accessories not recovered. Excavated 10'x10'x2' deep hole at corner location (in gravel road) and found nothing. Reestablished corner on extensions of old north-south fence lines and midway between remains of east-west fence lines 31' north and 31' south. This position checks well with corners east and west.

(7) Established corner equidistant and on a straight line between E7 and E8, both as recorded this date.
