Chippewa County Remonumentation Corner

LAND CORNER RECORDATION CERTIFICATE
Filing Requirement of Act 74, Mich. P.A. 1970

- A. Description of original monument and accessories and/or subsequent restoration:
(M-13) Township corner - Southeast Corner Section 36 (T44N-R2E), Southwest Corner Section 31 (T44N-R3E), Northeast Corner Section 1 (T43N-R2E) and Northwest Corner Section 6 (T43N-R3E).

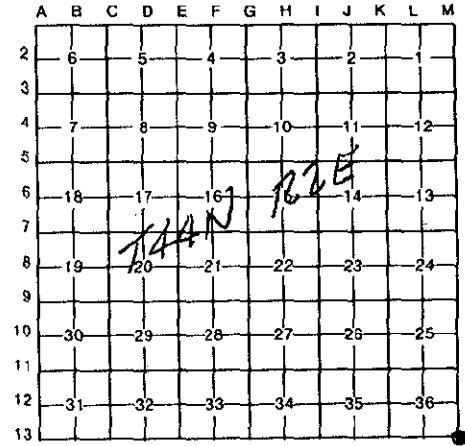
- C. Description of monument for corner and accessories established to perpetuate locating the position of the corner:
(M-13) Corner is a 3/4" x 8' rod with "Chippewa County" stamped aluminum cap. Area is heavy, open marsh with standing water.

Meander Corner 31/6 (R3E)	S89°17'38"E	432.96'
South 1/2 Corner Section 36	N89°17'38"W	2640.00'
Concrete Monument	S85°00'49"W	230.88'
Fiberglass Post	North	4.00'
Fiberglass Post	South	4.00'

Found no evidence of the original corner. Found remains of rotted post, 1 1/2" pipe and a newer concrete monument. All three are called for in a Harry Goodwin survey L.S. 5434, dated October 1976. Goodwin set the concrete monument. This evidence is significantly out of position based on other monumentation and GLO calls in the area. Distance from the Southwest corner of Section 36 to the South 1/2 corner of Section 36 is 2650' today which was also noted by Kimberly-Clark in 1963 (GLO is 2640). Both of these corners can be traced back to original evidence. If you extend this line East 2640' (GLO is 2640) and establish the Township Corner, the found Goodwin corner is 229'± West and 23'± South. (Continued on back)
