LAND CORNER RECORDATION CERTIFICATE
Filing Requirement of Act 74, Mich. P.A. 1970
Chippewa County Remonumentation Corner

(E-11) Section Corner Common to Sections 28, 29, 32 and 33, T.46 N., R.2 W.
This corner is being perpetuated as part of the Chippewa County Remonumentation Program.

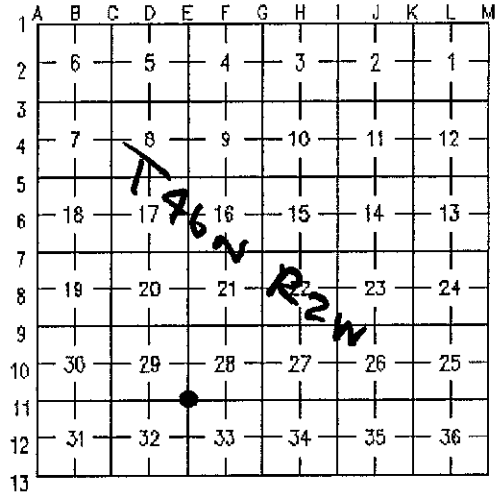
(E-11) Section Corner Common to Sections 28, 29, 32 and 33, T.46 N., R.2 W.
Corner is a 3/4" x 24" iron with aluminum Chippewa County Remonumentation Corner cap. Corner falls 30'± West of a North-South fence (West side of old lane).

Witnesses:	Steel fence post	North	1.00'
	R. Maple 18"	N52°E	12.34'
	S. Maple 4"	S56°E	5.70'
	R. Maple 5"	S80°W	23.43'
	R. Maple 5"	N38°W	18.51'

(E-11) Section Corner Common to Sections 28, 29, 32 and 33, T.46 N., R.2 W.
1849 Harvey Mellen set Spruce post in original survey. Witnesses: Spruce 8 N69°E 38
Y. Birch 9 S52°W 34
