Chippewa County Remonumentation Corner

LAND CORNER RECORDATION CERTIFICATE Filing Requirement of Act 74, Mich. P.A. 1970

A. Description of original monument and accessories and/or subsequent restoration:
(I-10) 1/4 Corner Common to Sections 26 and 27, T46N-R1E

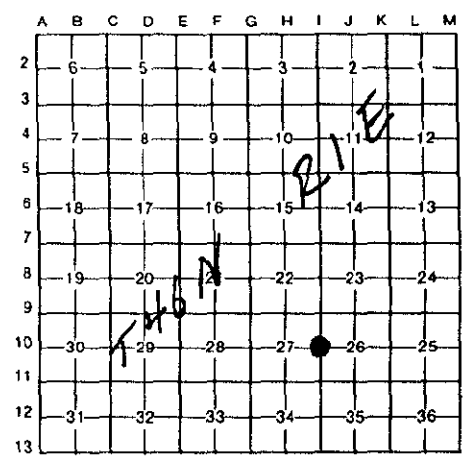
C. Description of monument for corner and accessories established to perpetuate locating the position of the corner:
(I-10) Corner is a 1/2" iron pin 2.5' West of centerline of Riverside Drive.

Witnesses: End Guard Rail Post	N08°W	102.60'
North Gate Post	N65°W	51.25'
Corner Fence Post	N88°W	46.10'
6" Elm	N85°E	90.42'
Corner Fence Post	S78°E	53.75'
1/2" Iron Pin	East	50.00'
