**LAND CORNER RECORDATION CERTIFICATE**  
**Filing Requirement of Act 74, Mich. P.A. 1970**

<u>Clare</u> <small>(County)</small>	Located In:	Corner Code #
1. Public Land Survey	<u>T18N R3W</u>	<u>G-3</u>
	T <u>    </u> R <u>    </u>	<u>    </u>
	T <u>    </u> R <u>    </u>	<u>    </u>
	T <u>    </u> R <u>    </u>	<u>    </u>
2. Property Controlling in Section	S <u>    </u> T <u>    </u> R <u>    </u>	<u>    </u>
	S <u>    </u> T <u>    </u> R <u>    </u>	<u>    </u>
3. Miscellaneous Property in Sec.	S <u>    </u> T <u>    </u> R <u>    </u>	<u>    </u>
	S <u>    </u> T <u>    </u> R <u>    </u>	<u>    </u>

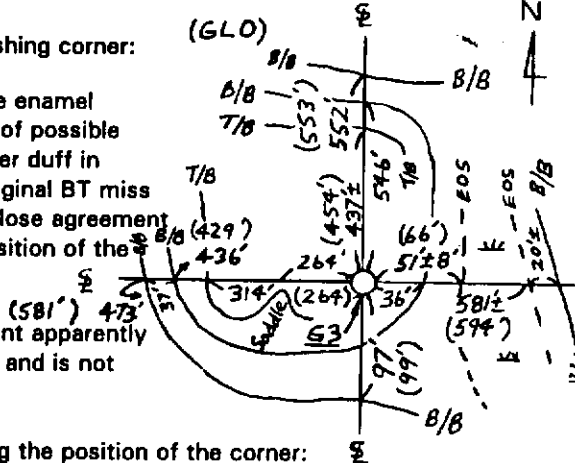
G3 - Sec. Cor Common to Sec. 3, 4, 9 & 10 - FND. 3/8" x 2.5' I.D. Iron Pipe with white enamel coating - Down 0.3' in Duff. Dug down 1.5' and found some small rotted remains of possible wood stake. S77°E 43.6' found remains of 18" hemlock - roots, knots & bark under duff in swamp. N19°E 25.3' to CL. of 26" R. Oak at GLO Maple BT location. Possibly original BT miss identified or secondary growth. Measure to GLO Topo calls N, E, S & W and find close agreement (see diagram). Monument accepted as a careful and faithful perpetuation of the position of the original corner.

Reference PT 'B' - FND. LS Cap 9433 on 1/2" Rebar - 20.53' Wly of G3. Monument apparently set without regard to FND. pipe. Monument established using improper procedures and is not utilized as G3 in this survey.

- G3 - Replace 3/8" x 2.5' Iron Pipe w/ 4" Department of Natural Resources Alum. Cap on 1" x 36" Iron Pipe in Ring of Stone. Reset 3/8" Pipe on S. Side as memorial and place Carsonite Post 2' N.  
 N19°E 25.59' to N&T in SE Side 26" R. Oak (GLO?)  
 S77°E 43.6' to Rotted remains 18" Hemlock - Set Spike (ADJ)  
 N40°W 8.11' to N&T in E. Side 18" Maple Clump Scribed 'XBT'  
 S20°W 66.14' to N&T in E. Side 14" Hemlock Scribed 'XBT'  
 S50°E 21.39' to N&T in SW Side 10" Beech Scribed 'XBT'  
 N55°E 6.36' to N&T in SE Side 8" Beech Scribed 'XBT'  
 S83° 47'W 20.53' to Capped Rebar - Reference PT 'B'
