**LAND CORNER RECORDATION CERTIFICATE**  
**Filing Requirement of Act 74, Mich. P.A. 1970**

For corners in  
CLARE

1. Public Land Survey	T	<u>20N</u>	R	<u>4W</u>	<u>E-4</u>
	T		R		<u>F-4</u>
	T		R		
	T		R		
2. Property Controlling in Section	S		T	R	
	S		T	R	
3. Miscellaneous Property in Sec.	S		T	R	
	S		T	R

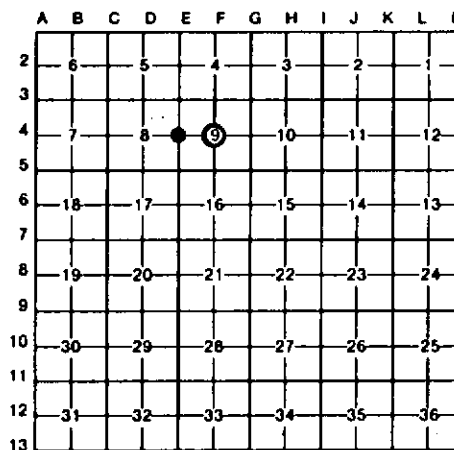
A. Description of original monument and accessories and/or subsequent restoration:  
 E-4                                      F-4                                      F-4 CONT'D

<b>E-4</b>	<b>F-4</b>	<b>F-4 CONT'D</b>
FD 1" SQ. X 42" ROD AS RECOVERED BY 1959 MSKD BAILEY DRIVE RELOCATION SURV; ROD WAS LYING DOWN IN 3" OF WATER OVER PEAT MUCK, REPLACED TO ORIGINAL POSITION FROM THREE MSKD 1959 NBT'S. FD NEWER 2-STRAND B-W ON TREE'S E'LY; NO EVIDENCE OF N-S FN.	RESTORED CTR. SEC. 9 AT PROPORTIONATE NEA. TO 1959 MSKD SURV. OF S-9 FOR BAILEY DRIVE RELOCATION (PROJ. 18034 RN-ORDER #5723). MSKD "FD CTR. POST, OLD WOOD STK. W/BLAZED CED. POST FOR MARKER", WHICH ALONG W/MSKD NBT'S WAS DESTROYED IN CONSTR. OF US-27 FREE-WAY. PAUL LAPHAM & ASSOC. USED MSKD COR'S & DATA TO SUBDIVIDE THE SE1/4-SE1/4 OF S-9; WHICH OUR	RESTORATION OF S1/4 & CTR. OF S-9 FITS ALMOST EXACTLY.

<b>E-4</b>	<b>F-4</b>	<b>F-4 CONT'D</b>
FD 1" SQ. IRON 3 1/2" LONG W/LOOP ON BOTTOM; ADDED CED POST.	DROVE 1" X 3/8" GALV. PIPE W/RLS CAP; SET CED. POST W/LOC TAG.	
7" CEDAR N27°E 15.1'	7" ELN N20°W 8.45'	
6" CEDAR N80°E 8.3'	10" ELN N70°E 4.62'	
5" CEDAR S25°E 19.1'	7" ELN S40°E 14.75'	
*12" CEDAR DUE W 8.75' (TOP BROKEN OUT)	CTR. S B LANE (US-27, INWAY) DUE E 86'
