LAND CORNER RECORDATION CERTIFICATE
Filing Requirement of Act 74, Mich. P.A. 1970

For corners in
DELTA
(County)

- 4. Lot No.
5. Private Claims
C-4 [W1/4 COR SEC 8] C-5 [NW COR SEC 17]

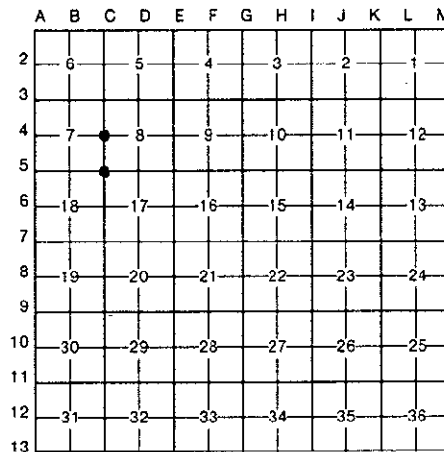
- C-4 [W1/4 COR SEC. 8] A.MERRYWEATHER, DS - 1848 - WOOD POST - (SUGAR 12" S40°E 04 LINKS)(BEECH 07" N45°W 27 LINKS) M.S.McNABB-1939-IRON IN PLACE-NO WIT'S NOTED M.DAVIS-1972-L.1 PG.24 LCR'S-FOUND 1' IRON BAR IN PLACE (C/L FENCE POST N45°W 2.30')(FENCE LINE SOUTH WEST 2.0')(FENCE LINE E-W NORTH 1.20')
C-5 [NW COR SEC 17] A.MERRYWEATHER,D.S. - 1848 - (CEDAR 12" N35°W 21 LINKS) (CEDAR 10" S32°E-25 LINKS) M.S.McNABB-1924-IRON IN PLACE-SUPV PLAT NO. 1 VILLAGE OF GARDEN & GARDEN TWP. LIBER "B" OF PLATS PAGE 42 M.S.McNABB-1939-IRON STAKE IN PLACE-NO WIT'S NOTED M.DAVIS RLS-1973-L.1 PG.405 LCR'S-FOUND IRON BOLT IN PLACE (TWIN BOX ELDER 18" N37°E 51.0')(BOX ELDER 18" N69°E 93.1')

- C-4 [W1/4 COR SEC. 8] FOUND IN PLACE A 1" IRON BAR AT JCT OF FENCE LINES E-W & S. MEASUREMENTS TO ADJOINING CORNERS INDICATES THE MONUMENT TO BE THE SAME AS MENTIONED IN McNABB'S 1939 FIELD NOTES. ID THE CORNER MONUMENT AS BEING THE SAME AS FOUND BY MYSELF IN 1972 FROM BT'S RECORDED AT L.1 OF LCR'S PG.24. ACCEPTED EXISTING MONUMENT AS BEING THE BEST AVAILABLE EVIDENCE AS TO THE POSITION OF THE ORIGINAL CORNER.
C-5 [NW COR SEC 17] FOUND IN PLACE A 3/4" IRON PIPE AS SET OVER AN EXISTING IRON BOLT BY MYSELF IN 1973. CORNER MONUMENT ID FROM THE PLAT OF THE SUPERVISOR'S PLAT OF THE VILLAGE OF GARDEN & GARDEN TWP. AS REC'D IN LIBER "B" OF PLATS ON PG.42 AND FROM BT'S REC'D AT L.1 OF LCR'S PG.405. ACCEPTED EXISTING MONUMENT AS BEING THE BEST AVAILABLE EVIDENCE AS TO THE POSITION OF THE ORIGINAL CORNER.
