LAND CORNER RECORDATION CERTIFICATE
Filing Requirement of Act 74, Mich. P.A. 1970

B-11 [N1/4 COR SEC 31] H-07 [N1/4 COR SEC 22]

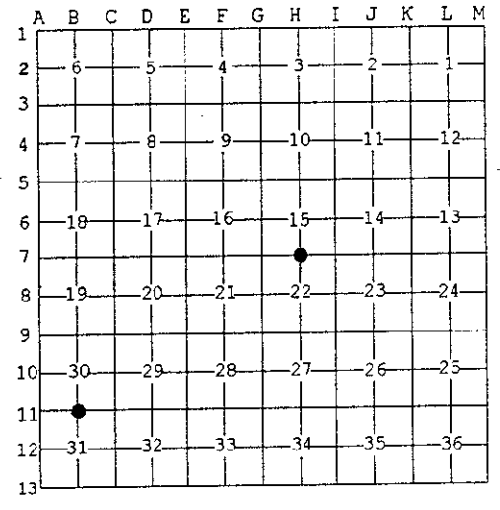
A. Description of original monument and accessories and/or subsequent restoration:

- B-11 [N1/4 COR SEC 31] A.MERRYWEATHER,D.S.-1848-WOOD POST (POPLAR 10" S30°W 13 LINKS)(TAMARACK 07" N10°E 02 LINKS) NO RECORD EVIDENCE OF CORNER RECOVERY AND/OR SUBSEQUENT MONUMENTATION.
- H-07 [N1/4 COR SEC 22] A.MERRYWEATHER,D.S.-1848-WOOD POST (POPLAR 04 EAST 06 LINKS)(TAMARACK 05" S45°W 20 LINKS) NO RECORD EVIDENCE OF CORNER RECOVERY AND/OR SUBSEQUENT MONUMENTATION.
