**SURVEY &
REMONUMENTATION**

**LAND CORNER RECORDATION CERTIFICATE
Filing Requirement of Act 74, Mich. P.A. 1970**

Approved By Delta County
Land Survey Remonumentation
Peer Group Under Act 345 Of
P.A. Of 1990 On August 30, 1993

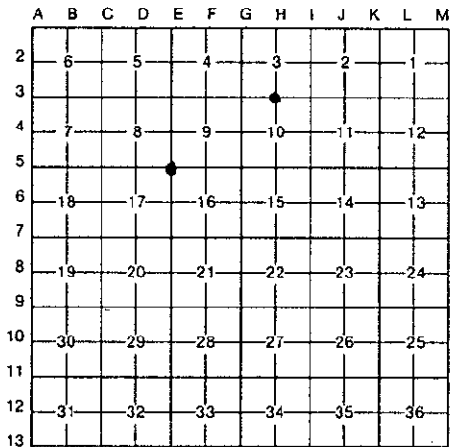
4. Lot No. _____, Recorded Plat _____
5. Private Claims _____
H-3 [1/4 COR COMMON TO SEC'S 3/10] E-5 [NW COR SEC 16]

H-3 [1/4 COR COMMON TO SEC'S 3/10] WOOD POST - A. MERRYWEATHER - 1846 (HEMLOCK 8"-WEST-13 LINKS) (W.PINE 4"-N75°E-8 LINKS)
M.S. McNABB - 1922 - ID FROM ORIGINAL HEMLOCK BT - (CEDAR STUMP 16"-S40°E-30.8') (CEDAR 7"-NORTH-12.8')
M. DAVIS - 1970 - FOUND IRON PIN IN ROAD - AS PER L.C.R.'S. IN LIBER 4 PAGE 184

E-5 [NW COR SEC 16] WOOD POST - A. MERRYWEATHER - 1846 (TAMERACK 10"-NORTH-1 LINK) (SPRUCE 6"-S62°W-3 LINKS)
D.A. BROTHERTON - 1895 - ID FROM BOTH ORIGINALS - NEW BT TAMERACK 14"-S11°45'W-22.5'
G. CARLSON - 1989 - FOUND SQ'D WOOD STAKE - AS PER L.C.R.'S. IN LIBER 6 PAGE 310
