LAND CORNER RECORDATION CERTIFICATE
Filing Requirement of Act 74, Mich. P.A. 1970

For corners in
DELTA

4. Lot No. _____, Recorded Plat _____
5. Private Claims C-1 [NW COR SEC 5] C-2 [W1/4 COR SEC 5]

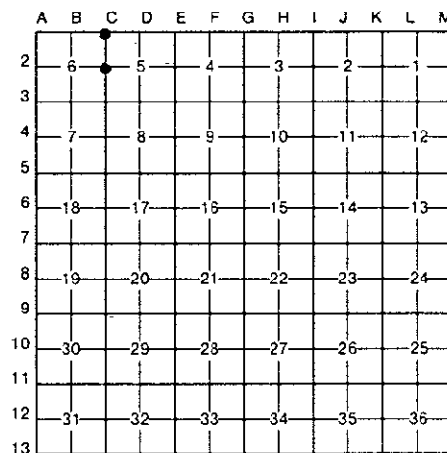
A. Description of original monument and accessories and/or subsequent restoration:
C-1 [NW COR SEC. 5] A.MERRYWEATHER, DS - 1848 - WOOD POST - (NORWAY PINE 18° S36°E 134 LINKS)
NO RECORD OF SUBSEQUENT CORNER RECOVERY AND/OR MONUMENTATION

B. Description of corner evidence found and/or method applied in restoring or reestablishing corner:
C-1 [NW COR SEC. 5] NO ACCEPTABLE CORNER EVIDENCE FOUND. REESTABLISHED CORNER POSITION ON FOURTH CORRECTION LINE NORTH & AT PROPORTIONATE POSITION EAST OF THE S1/4 COR OF SEC 33 T41N R19W. THIS POSITION FALLS 25.28' SOUTH & 69.72' WEST OF AN UNMARKED 3" WOOD POST AS IDENTIFIED BY TWO EXISTING BEARING TREES, A W. BIRCH NE, STILL GREEN & A R.PINE SE, DOWN. UPPER & LOWER BLAZES VISIBLE ON BOTH BT'S. UNABLE TO DETERMINE THE ORIGIN OF THE EXISTING WOOD POST MONUMENT.

C-1 SET BERNTSEN A1NB30 ALUM MONUMENT W/A 3 1/4" CAP STAMPED TO ID THE CORNER POSITION.
TAMARACK 08" R. PINE 16" SURVEY MONUMENT SIGN POST NOTE: IN OPEN MARSH NO OTHER
N71°E S34°E NORTH WIT'S AVAILABLE
112.75' 111.55' 2.30' (TO FACE)
