**SURVEY &
REMONUMENTATION**

LAND CORNER RECORDATION CERTIFICATE
Filing Requirement of Act 74, Mich. P.A. 1970

4. Lot No. _____, Recorded Plat _____
5. Private Claims _____
F-3 [N1/4 COR SEC 9] F-5 [N1/4 COR SEC 16]

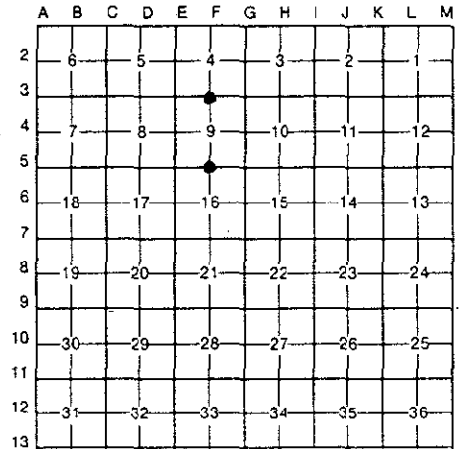
- A. Description of original monument and accessories and/or subsequent restoration:
F-3 [N1/4 COR SEC. 9] A.MERRYWEATHER, D.S. - 1848 - WOOD POST (CEDAR 06°-N12°W-08 LINKS) (TAMARACK 08°-SOUTH-04 LINKS)
NO RECORD EVIDENCE OF SUBSEQUENT CORNER RECOVERY AND/OR MONUMENTATION.
F-5 [N1/4 COR SEC. 16] A.MERRYWEATHER, D.S. - 1848 - WOOD POST (SPRUCE 06°-S10°E-11 LINKS) (SPRUCE 06°-N34°W-66 LINKS)
NO RECORD EVIDENCE OF SUBSEQUENT CORNER RECOVERY AND/OR MONUMENTATION.
