**SURVEY &
REMONUMENTATION**

**LAND CORNER RECORDATION CERTIFICATE
Filing Requirement of Act 74, Mich. P.A. 1970**

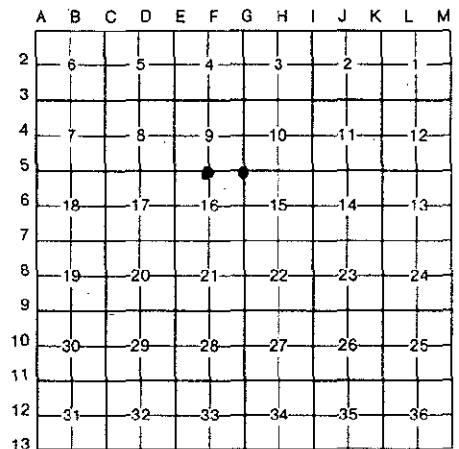
- A. Description of original monument and accessories and/or subsequent restoration:
F-5 [N1/4 COR SEC 16] WOOD POST - A. MERRYWEATHER, D.S. - 1848 - (SPRUCE 6"-S20°W-4 LINKS) (TAMERAC 12"-N47°E-15 LINKS)
M.S. McNABB - 1944 - FOUND IRON BOLT IN PLACE - NO NEW WIT'S. NOTED
G-5 [NW COR SEC 15] WOOD POST - A. MERRYWEATHER, D.S. - 1846 - (CEDAR 8"-S18°E-7 LINKS) (CEDAR 8"-N15°W-13 LINKS)
F.J. MERRIAM - 1895 - SET LENGTH OF RAIL - PLAT OF FURNACE ADD TO GLADSTONE - REC'D LIBER "B" OF PLATS PAGE 8 - NO WIT'S NOTED
TESTIMONY TO ME, THIS DATE, BY LOCAL PROPERTY OWNER THAT SOMETIME AGO HE REMOVED THE LENGTH OF RAI AS IT HINDERED HIS ENTRANCE INTO HIS GARAGE.
