LAND CORNER RECORDATION CERTIFICATE  
Filing Requirement of Act 74, Mich. P.A. 1970

1. Public Land Survey	T <u>40 N</u> R <u>22 W</u>	<u>G-3 &amp; H-3</u>
	T _____ R _____	_____
	T _____ R _____	_____
	T _____ R _____	_____
2. Property Controlling in Section	S _____ T _____ R _____	_____
	S _____ T _____ R _____	_____
3. Miscellaneous Property in Sec.	S _____ T _____ R _____	_____
	S _____ T _____ R _____	_____

- 4. Lot No. \_\_\_\_\_, Recorded Plat \_\_\_\_\_
- 5. Private Claims \_\_\_\_\_  
[G-3] NW COR SEC 10 [H-3] N1/4 COR SEC 10

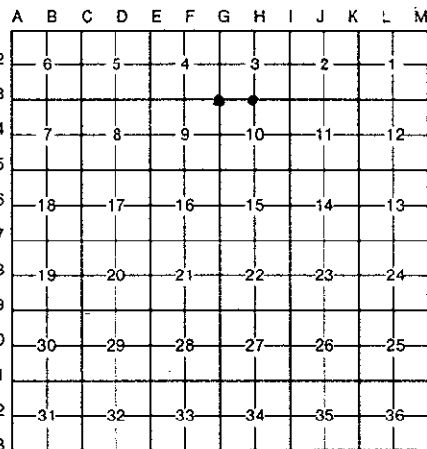
G-3 [NW COR SEC 10] WOOD POST - A. MERRYWEATHER, D.S. - 1846 (CEDAR 10°-S30°E-22 LINKS) (CEDAR 8°-N37°W-10 LINKS)  
 JOSEPH E. GINGRASS - 1906 - ID FROM ORIGINALS - NO NEW WIT'S NOTED  
 M.S. McNABB - 1922 - FOUND STAKE IN PLACE (CEDAR STUMP 14°-S50°W-8') (CEDAR STUMP 12°-S20°E-14')  
 M.S. McNABB - 1944 - STAKE IN PLACE (CEDAR 5°-N30°E-21') (CEDAR 4°-S52°W-13')  
 M.D.O.T. DATE UNKNOWN - FOUND 4' WOOD POST - (CEDAR 5°-S45°W-14/5') (CEDAR 8°-N40°E-21.4') (MAPLE 3°-S50°E-29.50')

G-3 [NW COR SEC 10] FOUND REMAINS OF SQ'D. CEDAR POST & STUMPS OF M.D.O.T. CEDAR BTS  
 ID CORNER MON FROM M.D.O.T. TIES TO HWY U.S. 2 & 41 R/W  
 ACCEPTED EXISTING COR AS BEING A CAREFUL & FAITHFUL PERPETUATION OF THE POSITION OF THE ORIGINAL CORNER.
