SURVEY & REMONUMENTATION

LAND CORNER RECORDATION CERTIFICATE Filing Requirement of Act 74, Mich. P.A. 1970

For corners in
DELTA
(County)

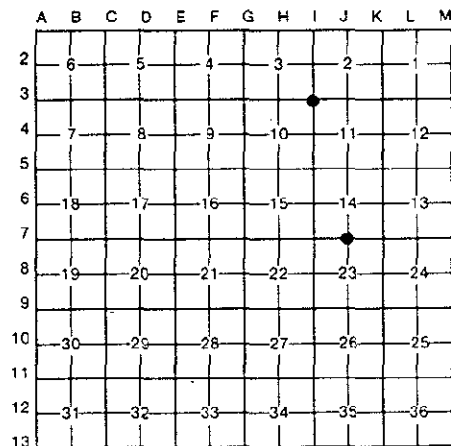
4. Lot No. _____, Recorded Plat _____
5. Private Claims I-03 [NW COR S.11] J-07 [N1/4 S.23]

- A. Description of original monument and accessories and/or subsequent restoration:
- I-03 [NW COR SEC 11] A.MERRYWEATHER-1847-IN PLACE-(TAMARACK 08°-N45°W-11 LINKS)(TAMARACK 08°-S55°E-12 LINKS) D.A.BROTHERTON-1908-STAKE IN PLACE-ID BY ORIGINAL TAM BT NW & WITNESS TREE (CEDAR POST N50°E-9.6')(POPPLE 4"-S80°E-16.4)
- J-07 [N1/4 COR SEC 23] A.MERRYWEATHER,D.S. - 1847 - WOOD POST - (N.PINE 12°-N28°W-14 LINKS)(N.PINE 12°-SOUTH-06 LINKS) M.S.McNABB-NO COR TO BE FOUND ESTABLISHED BETWEEN CORNERS-SET STAKE & IRON (NO WIT'S NOTED) M.DAVIS-1971-FOUND IN PLACE 1" IRON PIPE-ID CORNER BY MEASUREMENT E & W 1/2 MILE TO SECTION CORNERS WHICH CHECKS WELL WITH REC'DS OF McNABB. (W.BIRCH 09°-N75°E-19.7')(W.PINE 06°-N38°W-20.1)(W.BIRCH 08°-S23°W-13.25)

- B. Description of corner evidence found and/or method applied in restoring or reestablishing corner:
- I-03 [NW COR SEC 11] FOUND IN PLACE, AT THE JCT OF OLD FENCE LINES E-W & S, A 1" IRON PIPE & REMAINS OF A SQ'D CEDAR POST (NO SCRIBING VISIBLE). NO EVIDENCE OF ORIG BT'S OR BROTHERTON'S 1908 BT'S ACCEPTED EXISTING MONUMENT AS BEING THE BEST AVAILABLE EVIDENCE AS TO THE POSITION OF THE ORIGINAL CORNER.
