LAND CORNER RECORDATION CERTIFICATE

Filing Requirement of Act 74, Mich. P.A. 1970

Norway Twp.

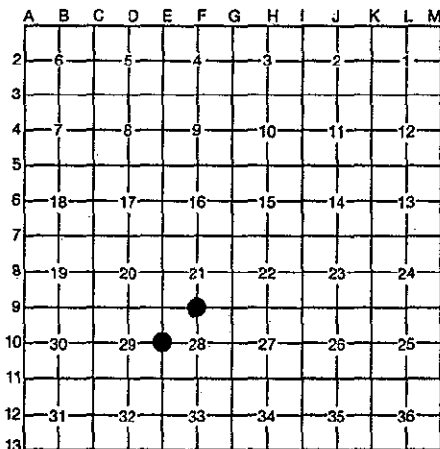
E-10 1/4 Corner 29/28
Post by James Mullett, D.S. 1849
Original Bearing Trees
White Ash 12" S80°W 20 Lks.
Cedar 12" S47°E 10 Lks.

F-9 1/4 Corner 28
Post by James Mullett, D.S. 1849
Original Bearing Trees
Hemlock 12" S50°E 7 Lks.
Hemlock 6" N32°W 12 Lks.

E-10 No Evidence of Original Corner or Accessories Found.
Found Iron Pipe at Fence Corner.
Old Fences run South, East & West.
(Fences are Down) Paint Line runs North and East.
Corner Location Researched in 1996.

F-9 No Evidence of Original Corner or Accessories Found.
Found 5/8" Iron Bar at old Cedar Post with old Fences running North, East and South. Location agrees with Dickinson County Road Commission Surveys of 1911 and 1932.
Corner Location Researched in 1996.
